Figures

**Figure 1-1**  
**Geographic Boundaries of the CMS**  
Former ASARCO East Helena Facility  
Corrective Measures Study Report  
East Helena, Montana

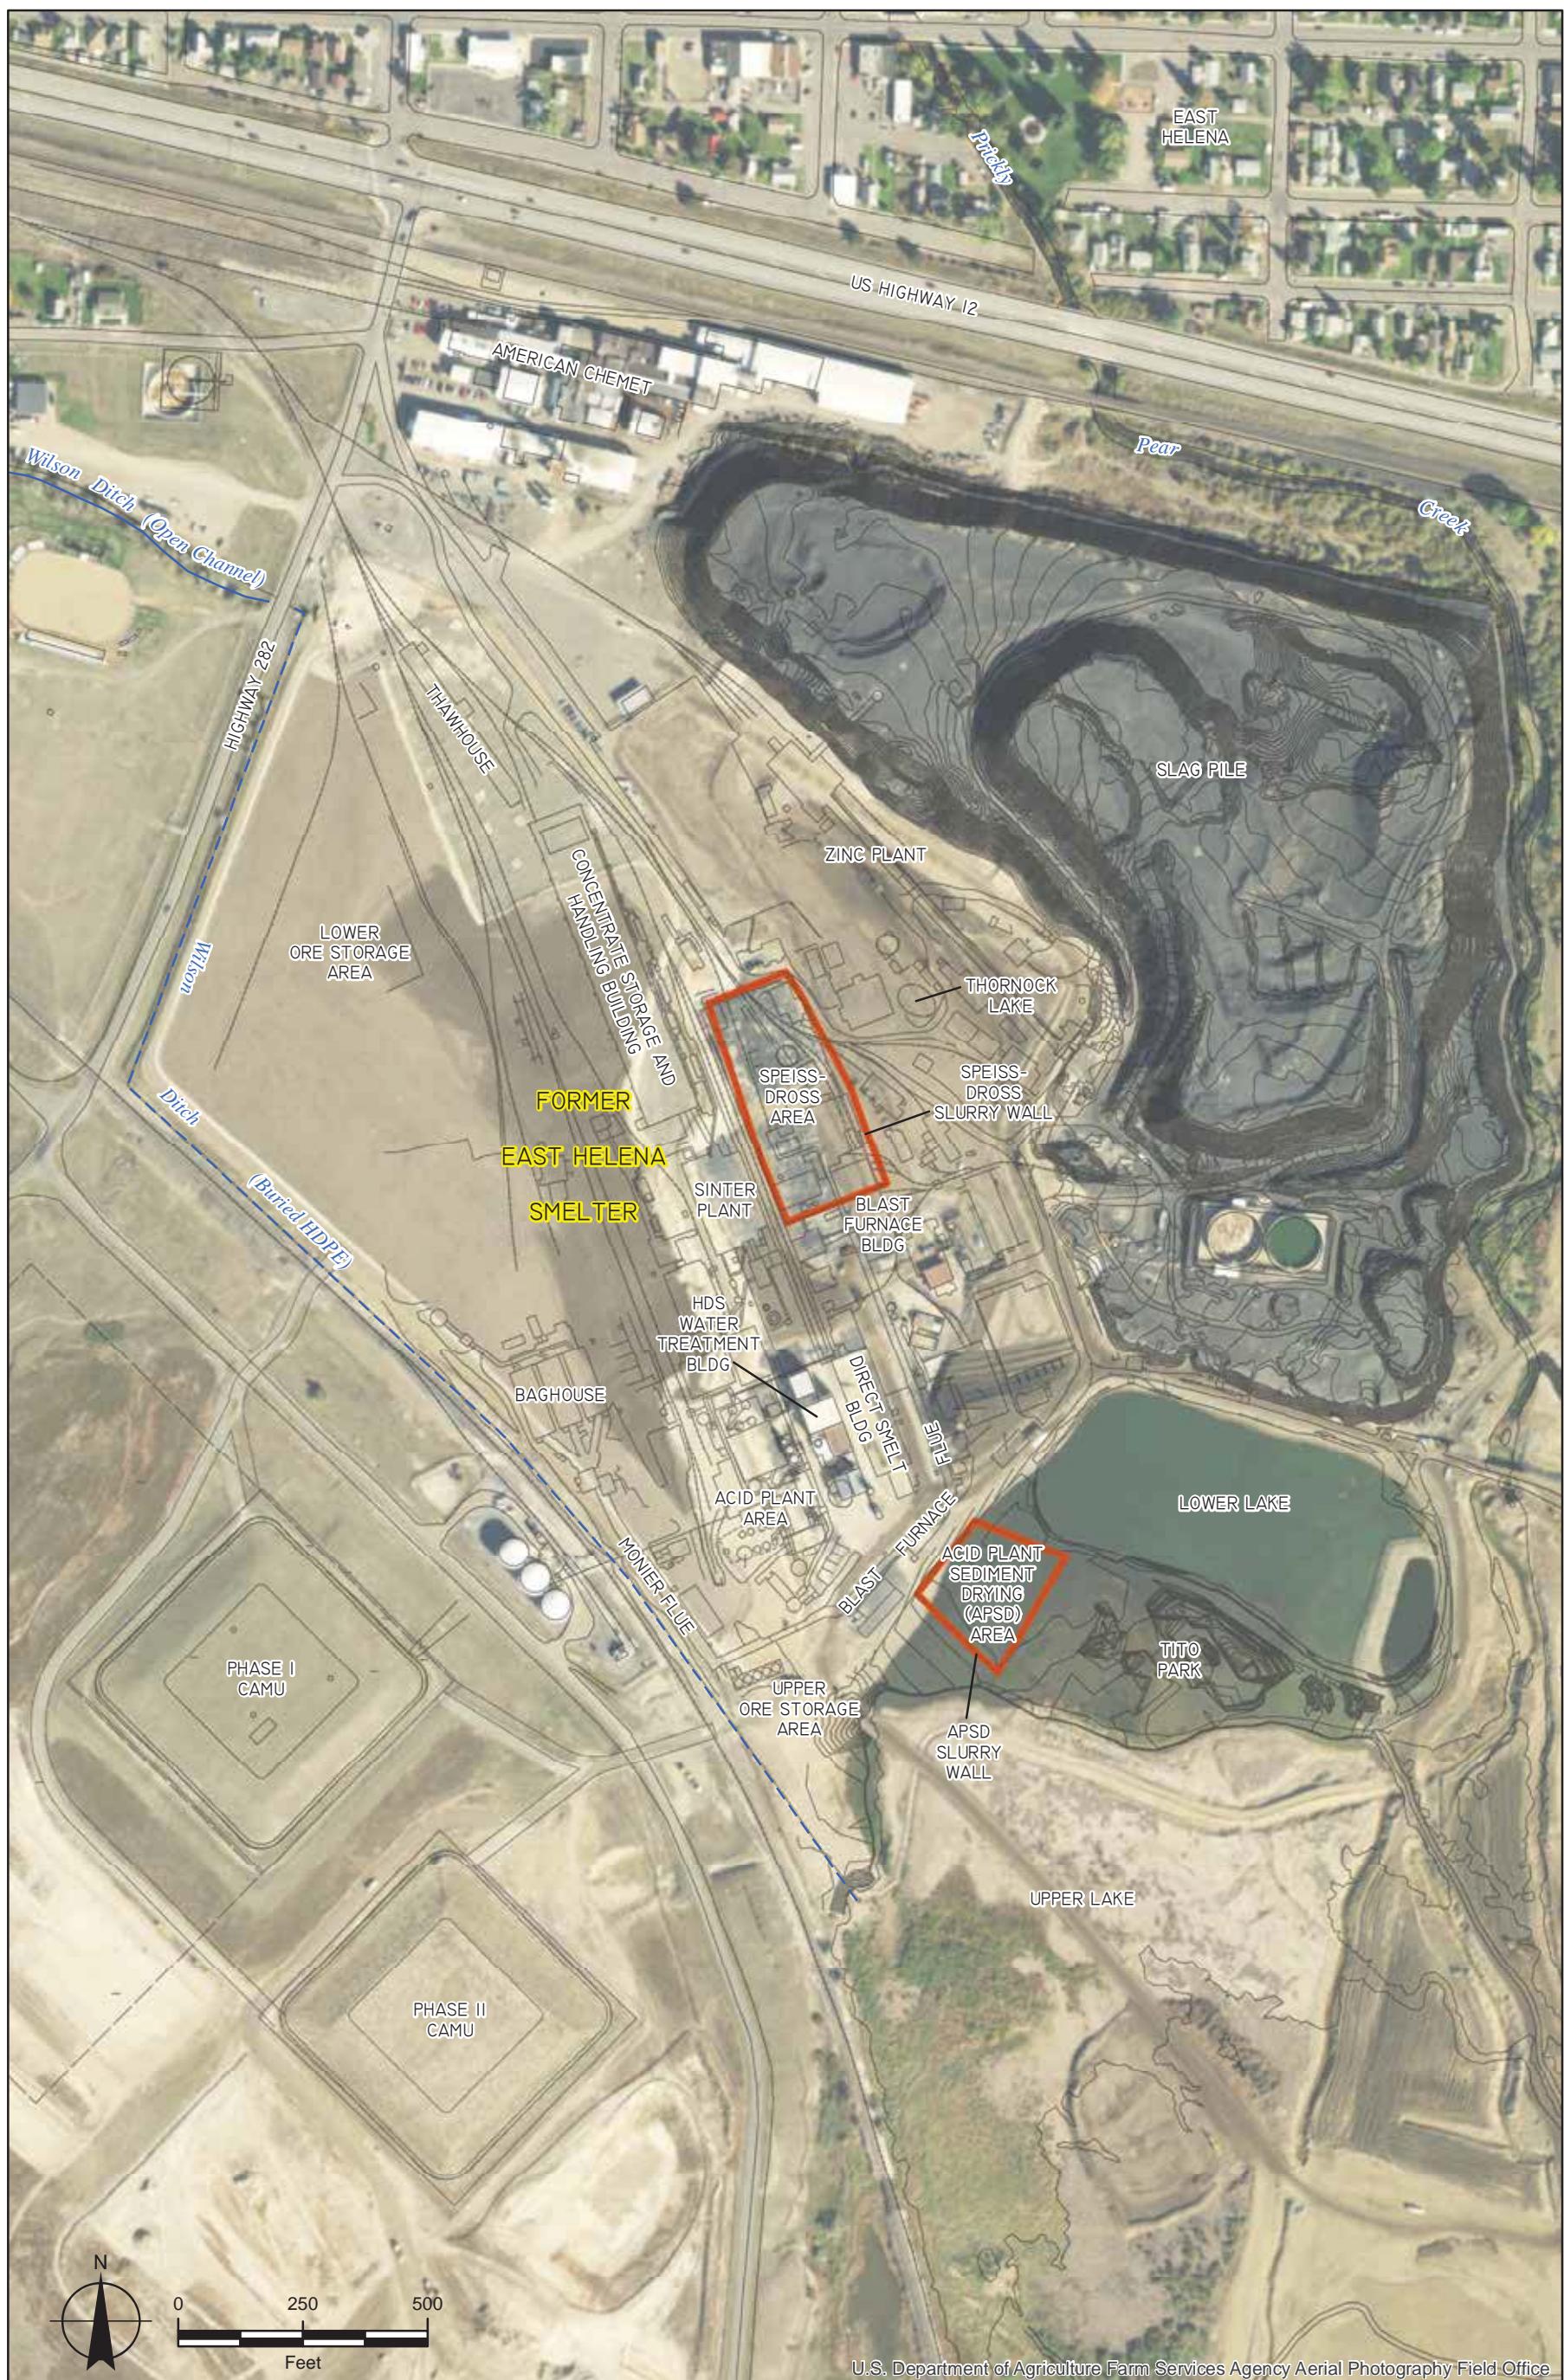
**Figure 1-2**  
**Site Areas and Features**  
*Former ASARCO East Helena Facility  
 Corrective Measures Study Report  
 East Helena, Montana*

Aerial photo date: September 2015

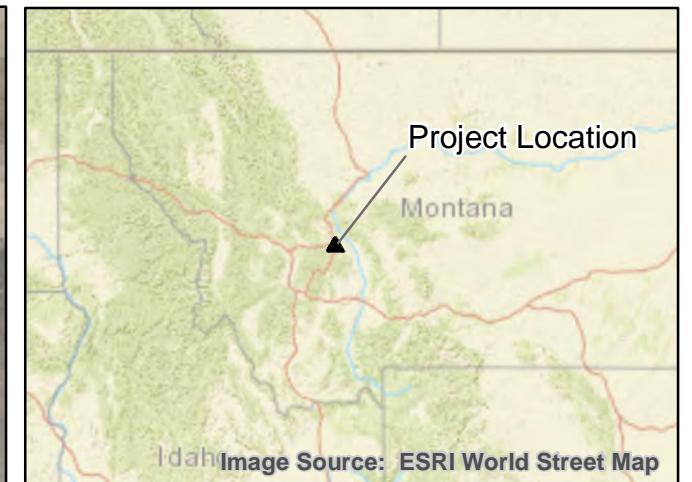
**Figure 2-1**  
**Reasonably Anticipated Land Use**  
Former ASARCO East Helena Facility  
Corrective Measures Study Report  
East Helena, Montana

Land uses shown are consistent with COEH zoning as approved by the Zoning Commission in November 2016. Effective December 15, 2016. Current use of Custodial Trust Parcels are legal non-conforming until the properties change hands.

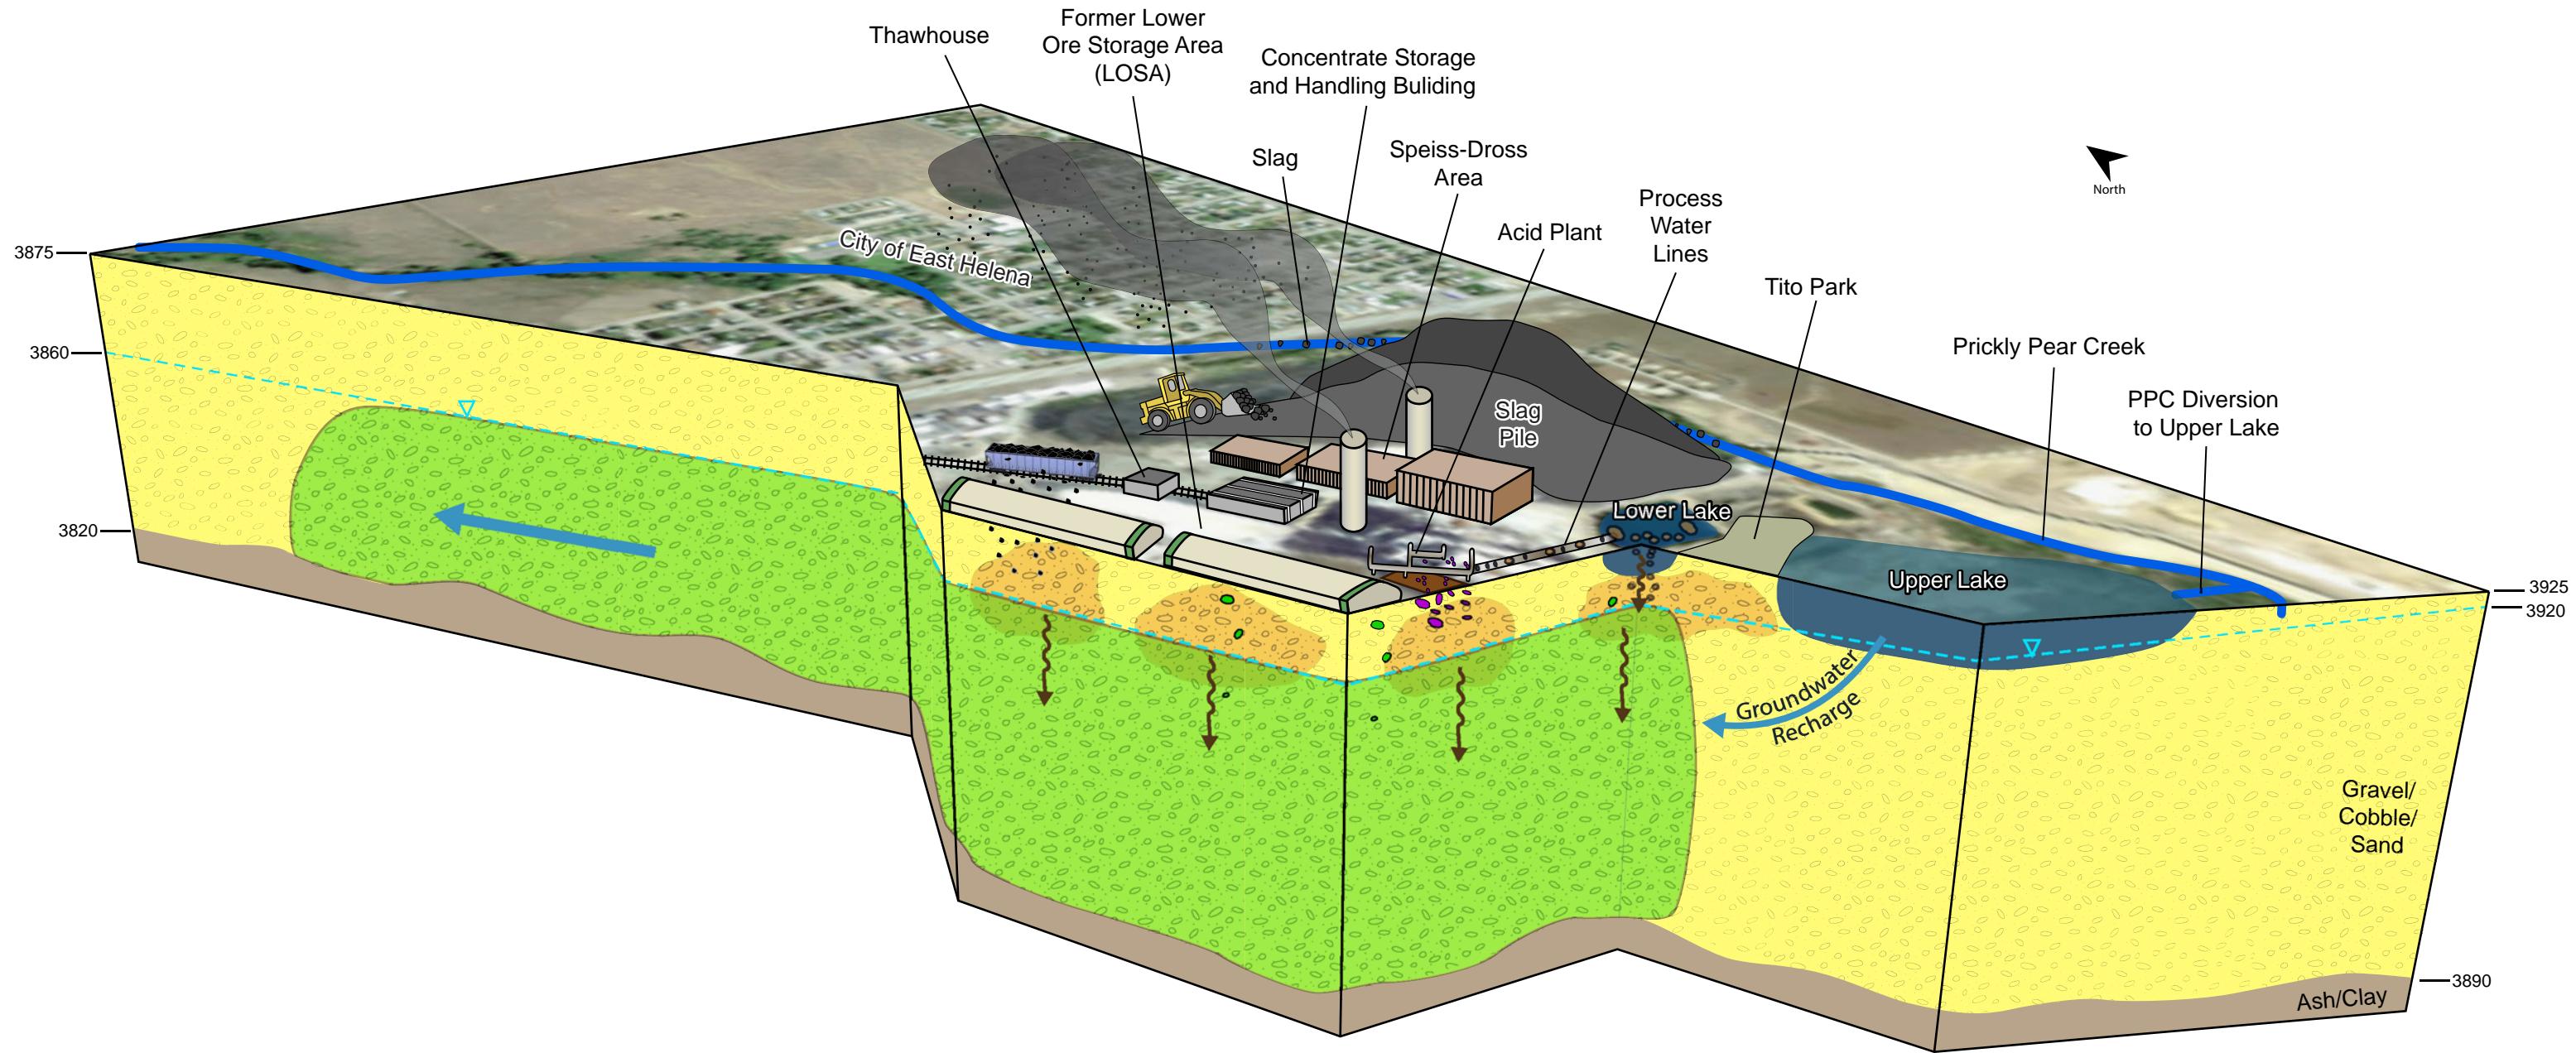
**Figure 3-1**  
**Conceptual Model of Operational Smelter**  
**(Through 2001)**  
Former ASARCO East Helena Facility  
Corrective Measures Study Report  
East Helena, Montana

NOTE:  
Darker colors represent higher contaminant concentrations.

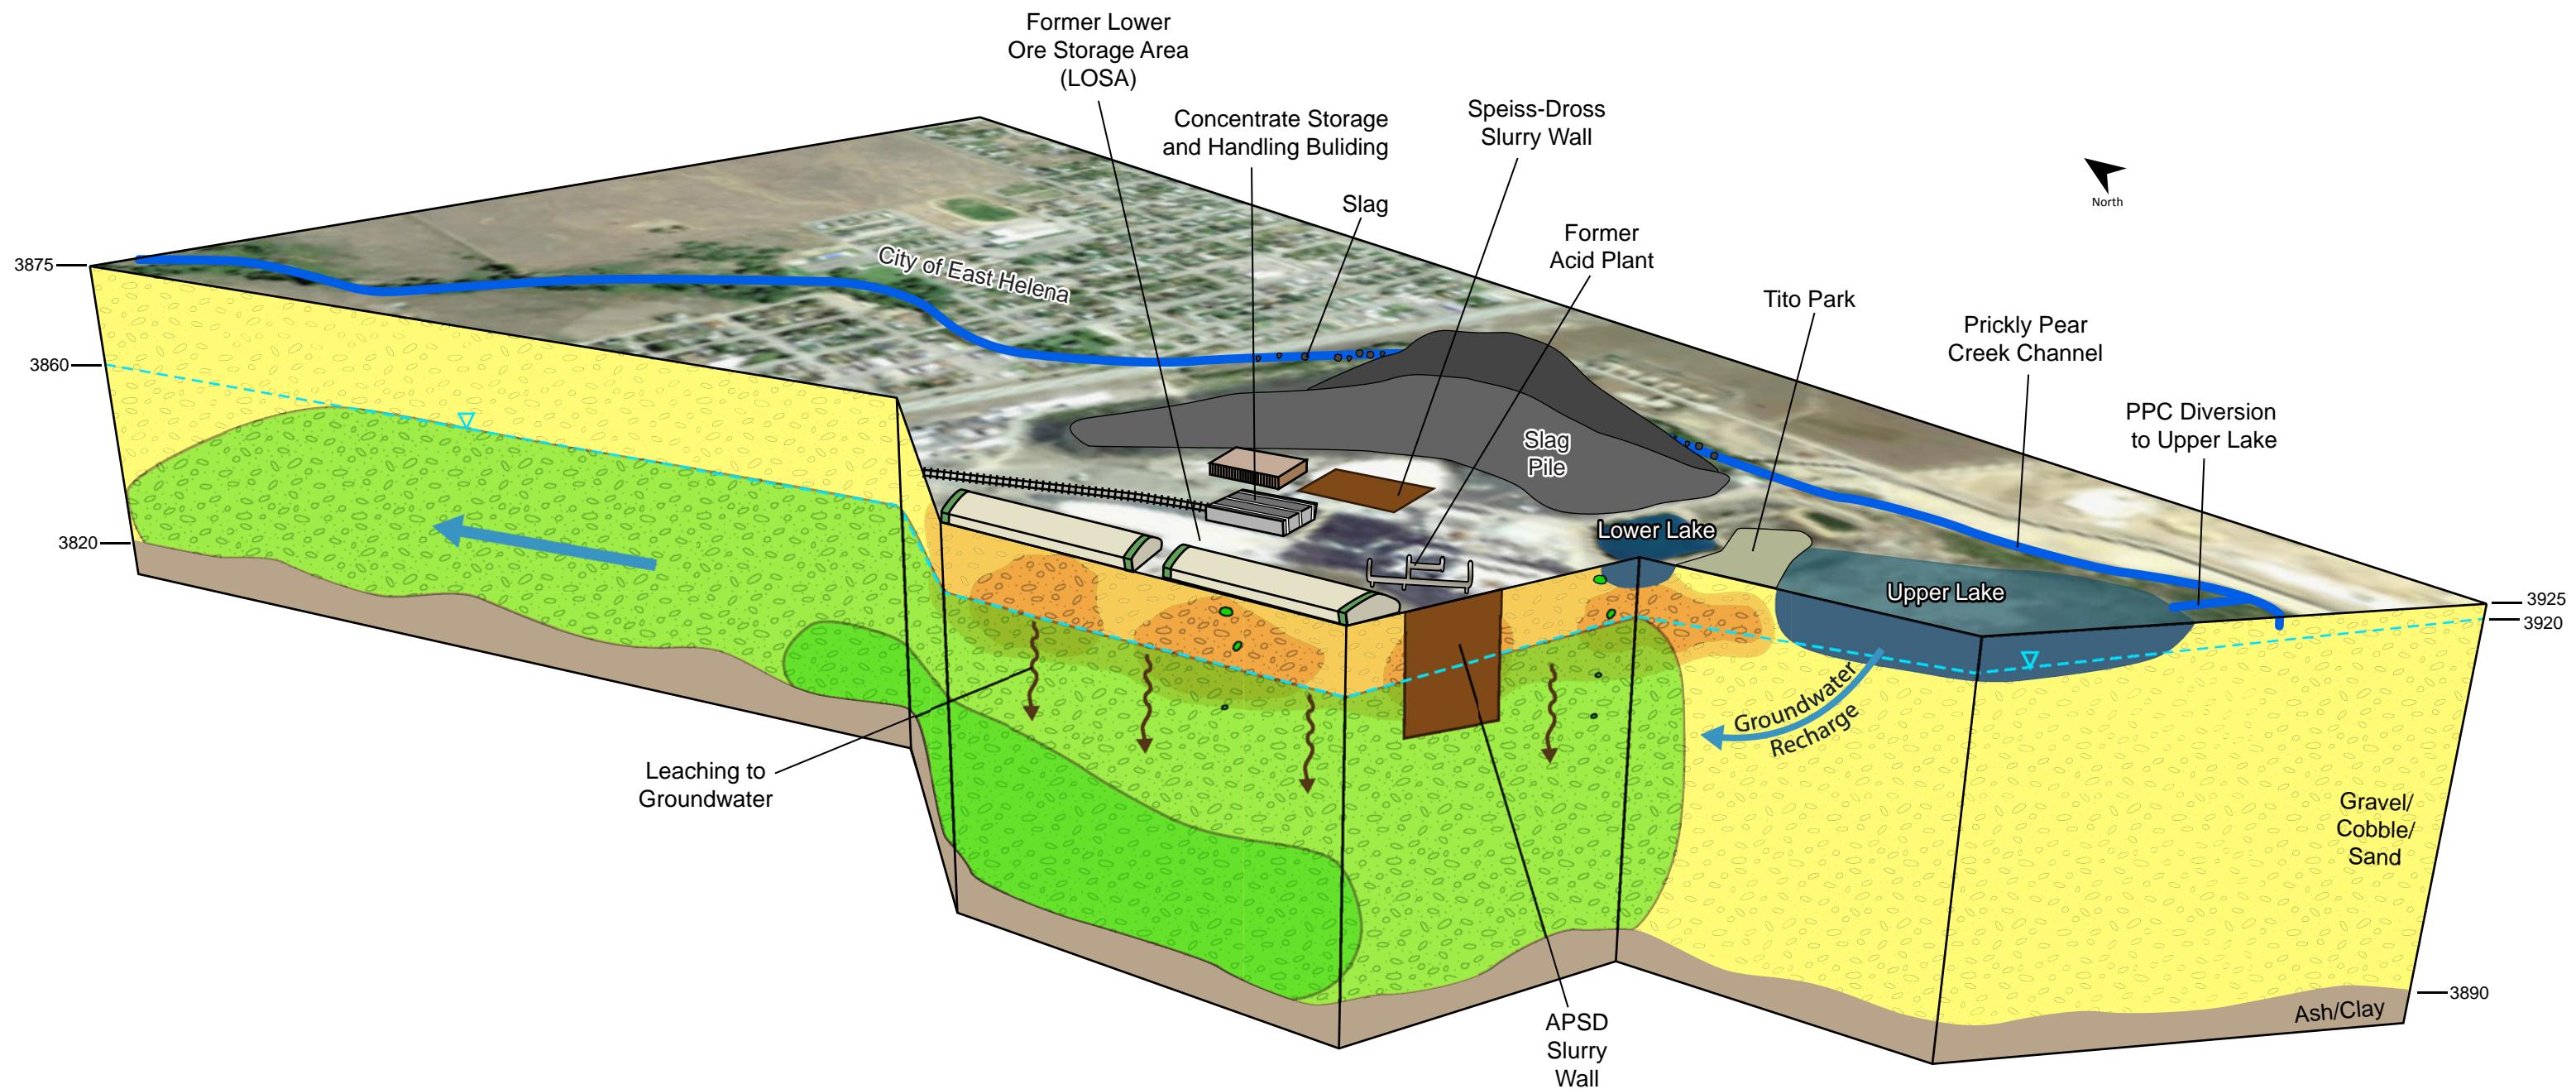
**Figure 3-6**  
**Conceptual Model of Post-Operational Smelter (2011)**  
Former ASARCO East Helena Facility  
Corrective Measures Study Report  
East Helena, Montana

NOTE:  
Darker colors represent higher contaminant concentrations.  
APSD - Acid plant sediment drying bed

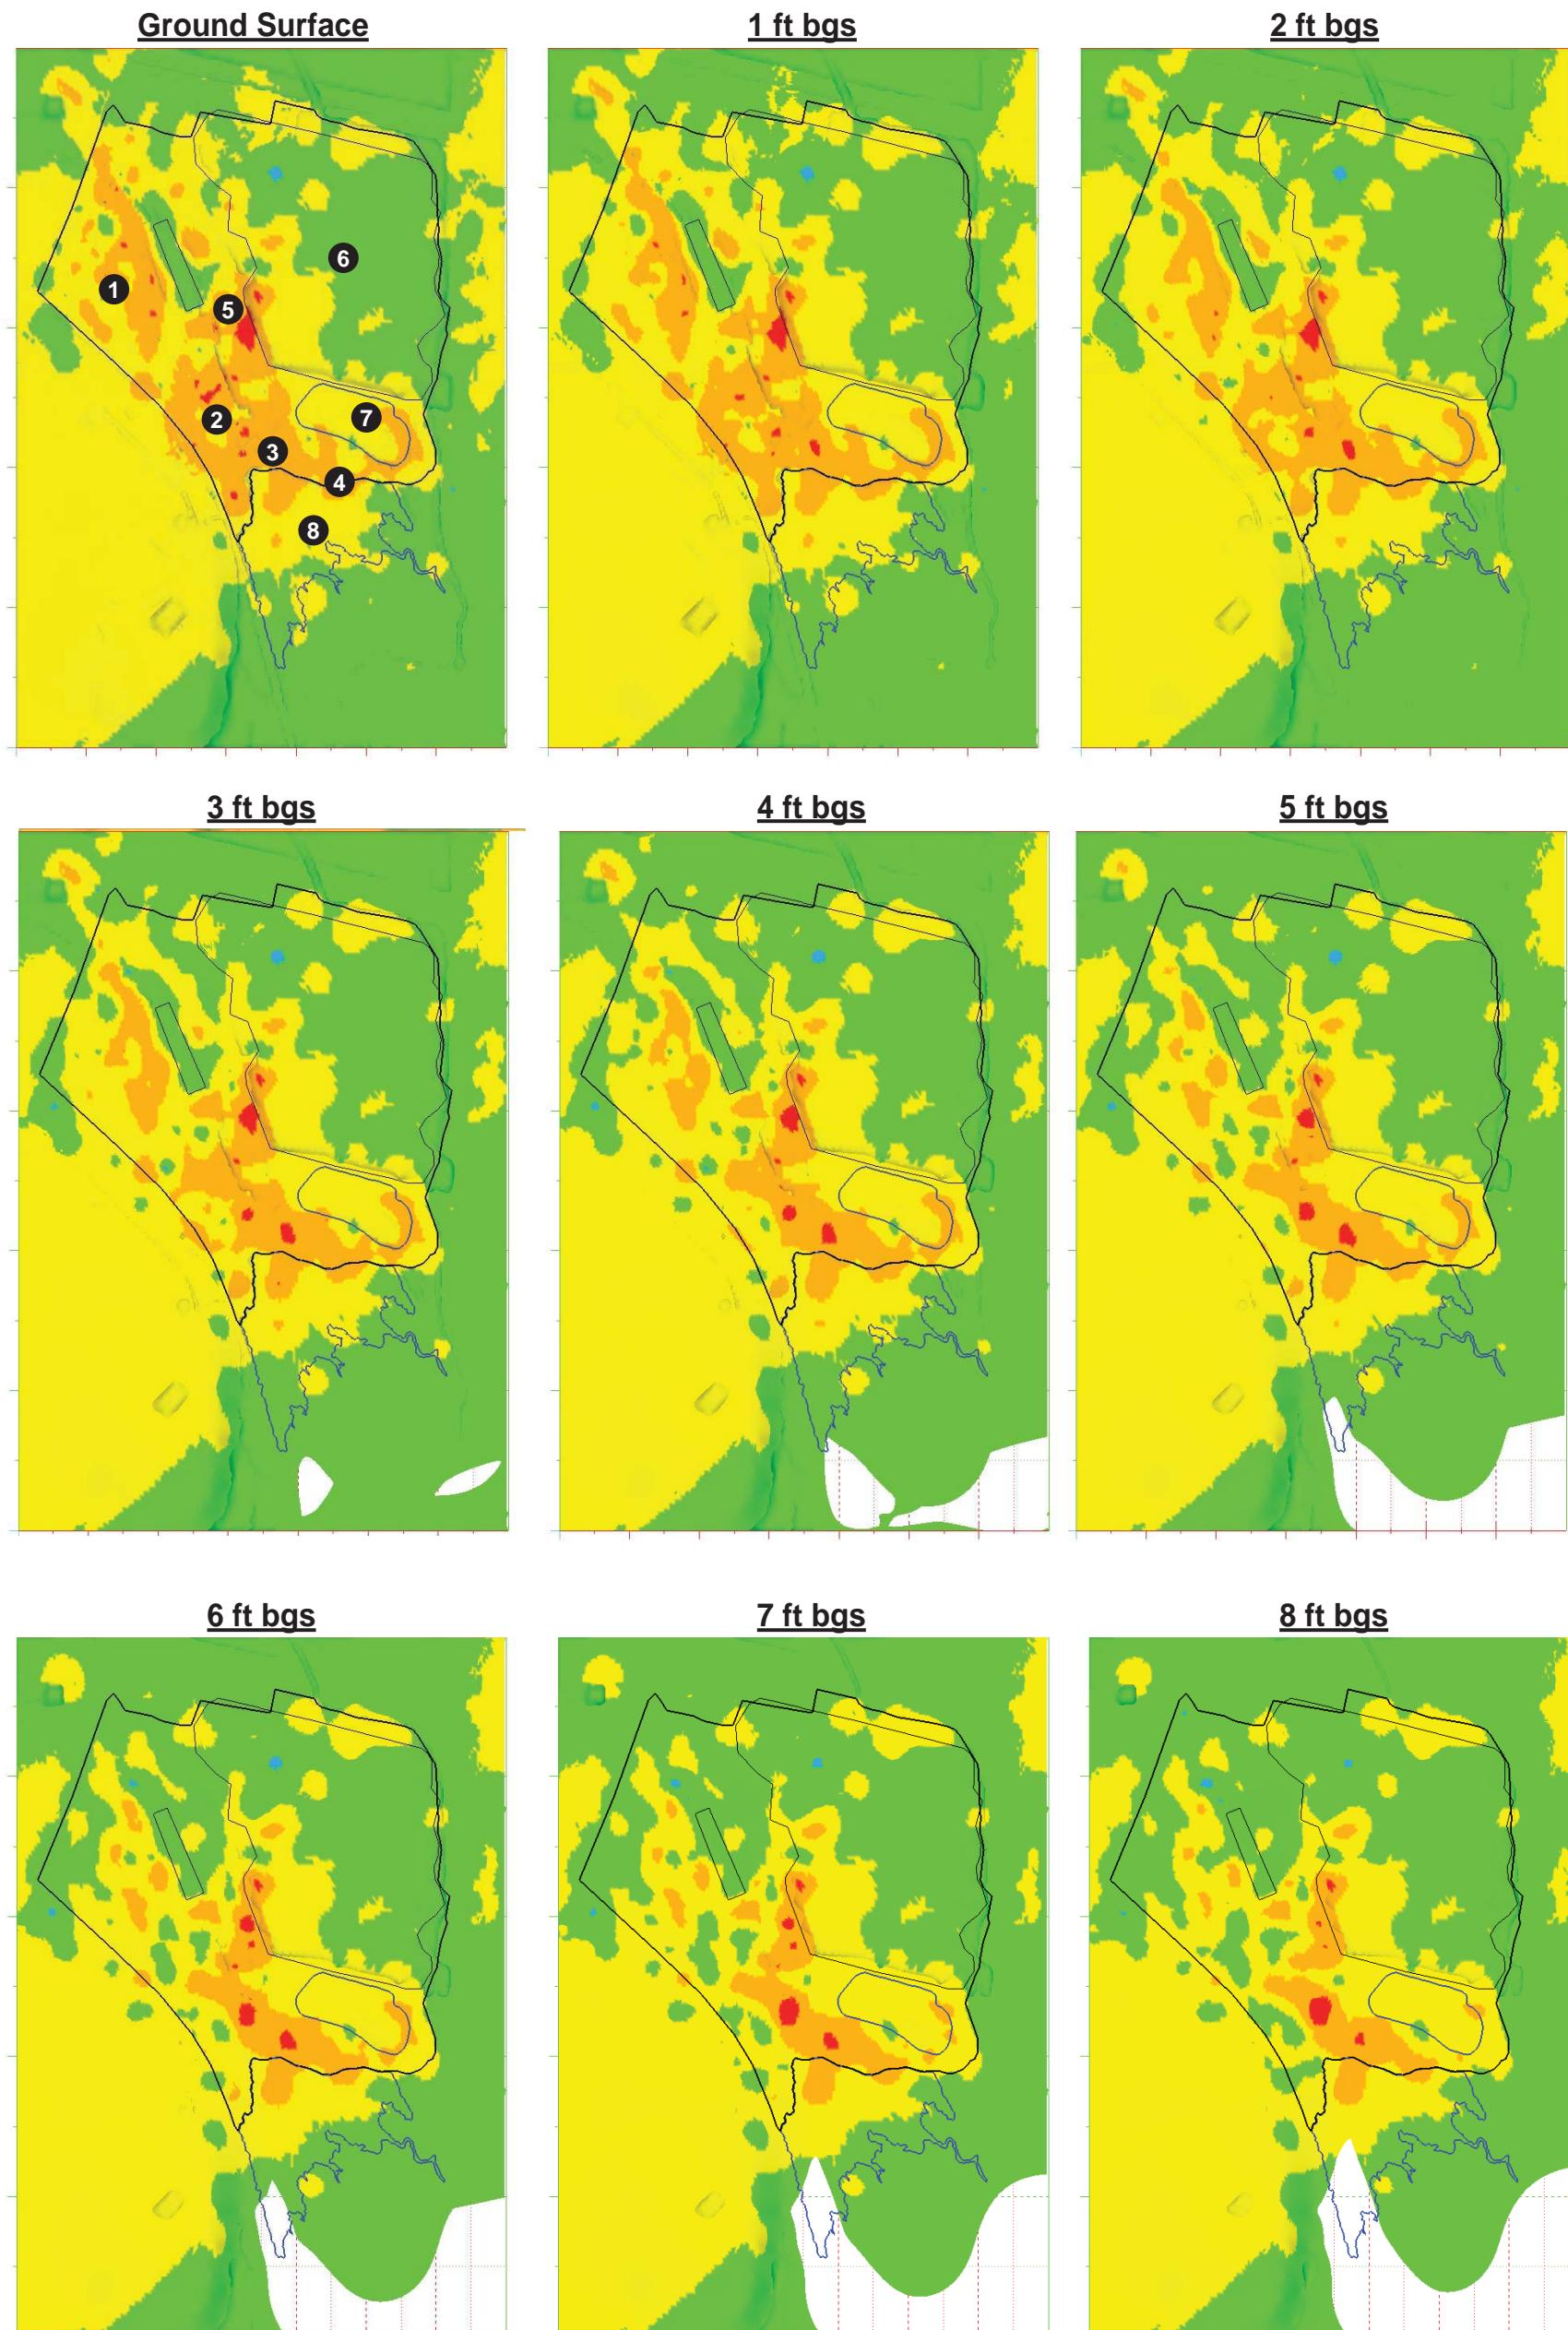
**Figure 3-12**  
**Arsenic Contamination, Ground Surface to Depth of 8 Feet**  
*Former ASARCO East Helena Facility*  
*Corrective Measures Study Report*  
*East Helena, Montana*

\* Red indicates highest concentrations of Arsenic remaining in soils at the site followed by orange and then yellow. Green is considered background concentrations.

White area of 3-ft bgs to 8-ft bgs figures corresponds to the Tertiary ash/clay layer.  
Figure developed to support soil removal evaluations using Mining Visualization System Software from 2012 through 2013.

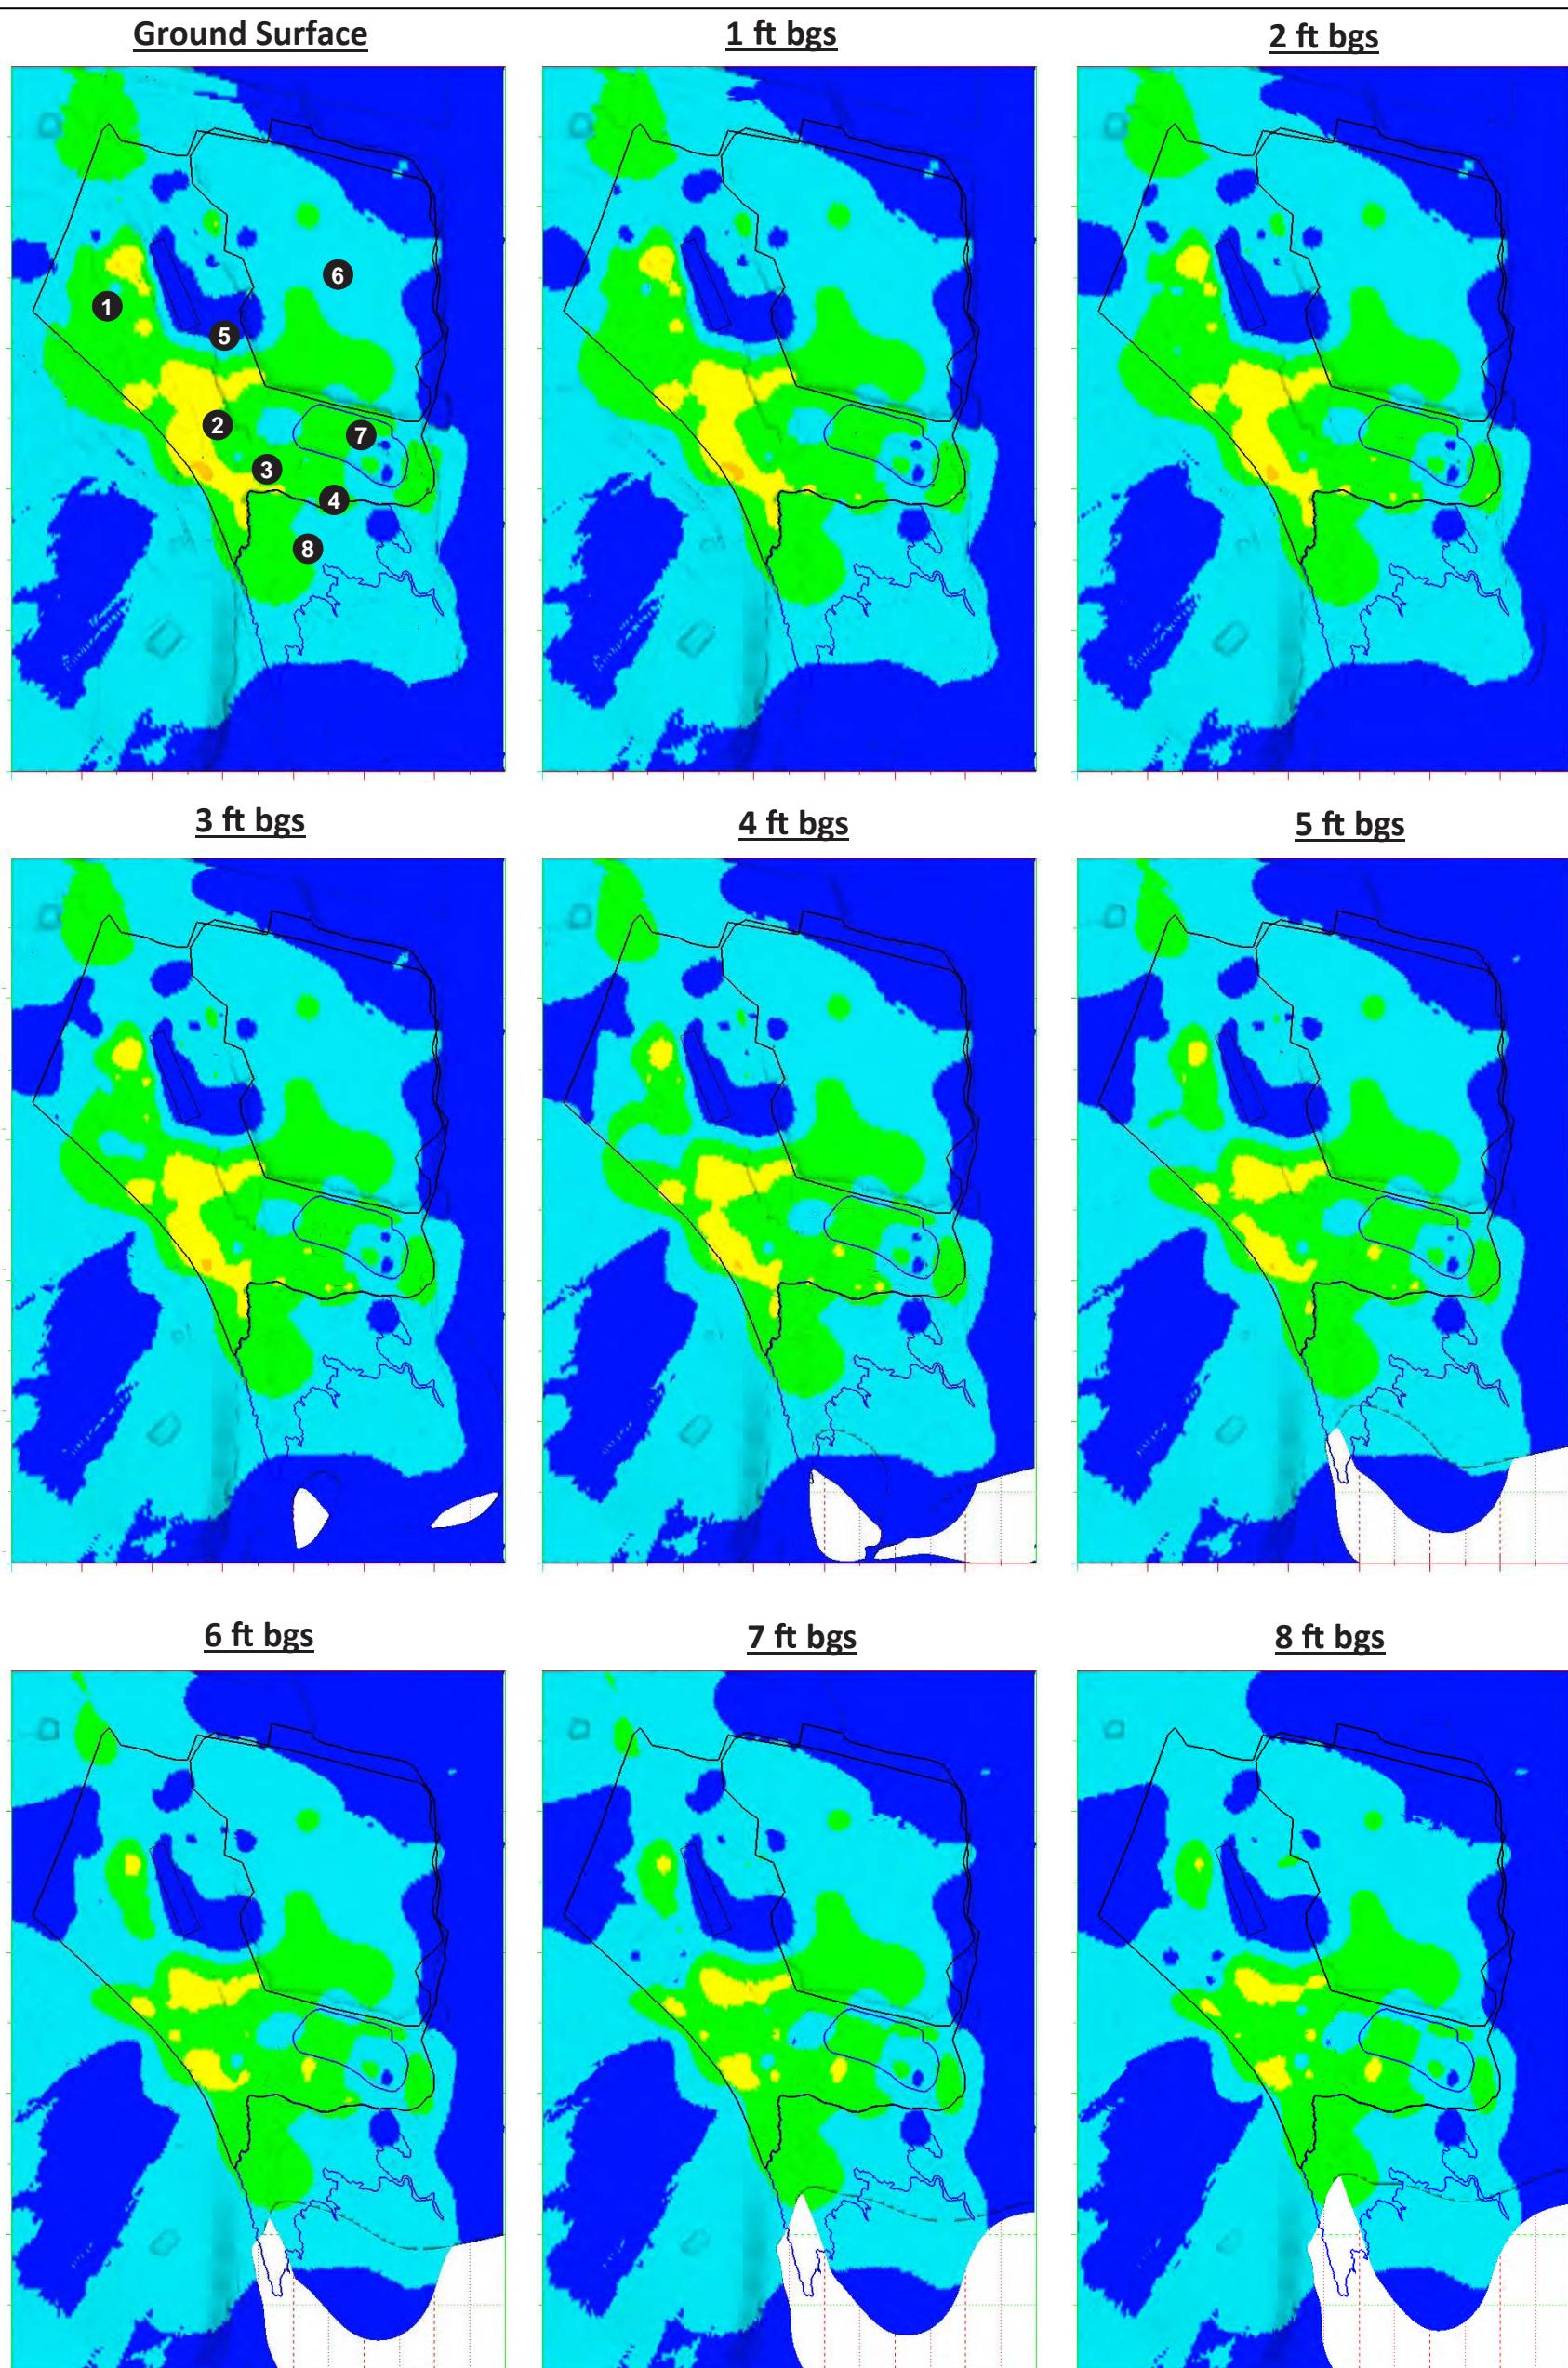
**Figure 3-13**  
**Selenium Contamination, Ground Surface to Depth of 8 Feet**  
**Former ASARCO East Helena Facility**  
**Corrective Measures Study Report**  
**East Helena, Montana**

\* Orange indicates highest concentrations of Selenium remaining in soils at the site followed by yellow and then green. Blues are considered background concentrations.

Notes:  
White area of 3-ft bgs to 8-ft bgs figures corresponds to the Tertiary ash/clay layer.  
Figure developed to support soil removal evaluations using Mining Visualization System Software from 2012 through 2013.

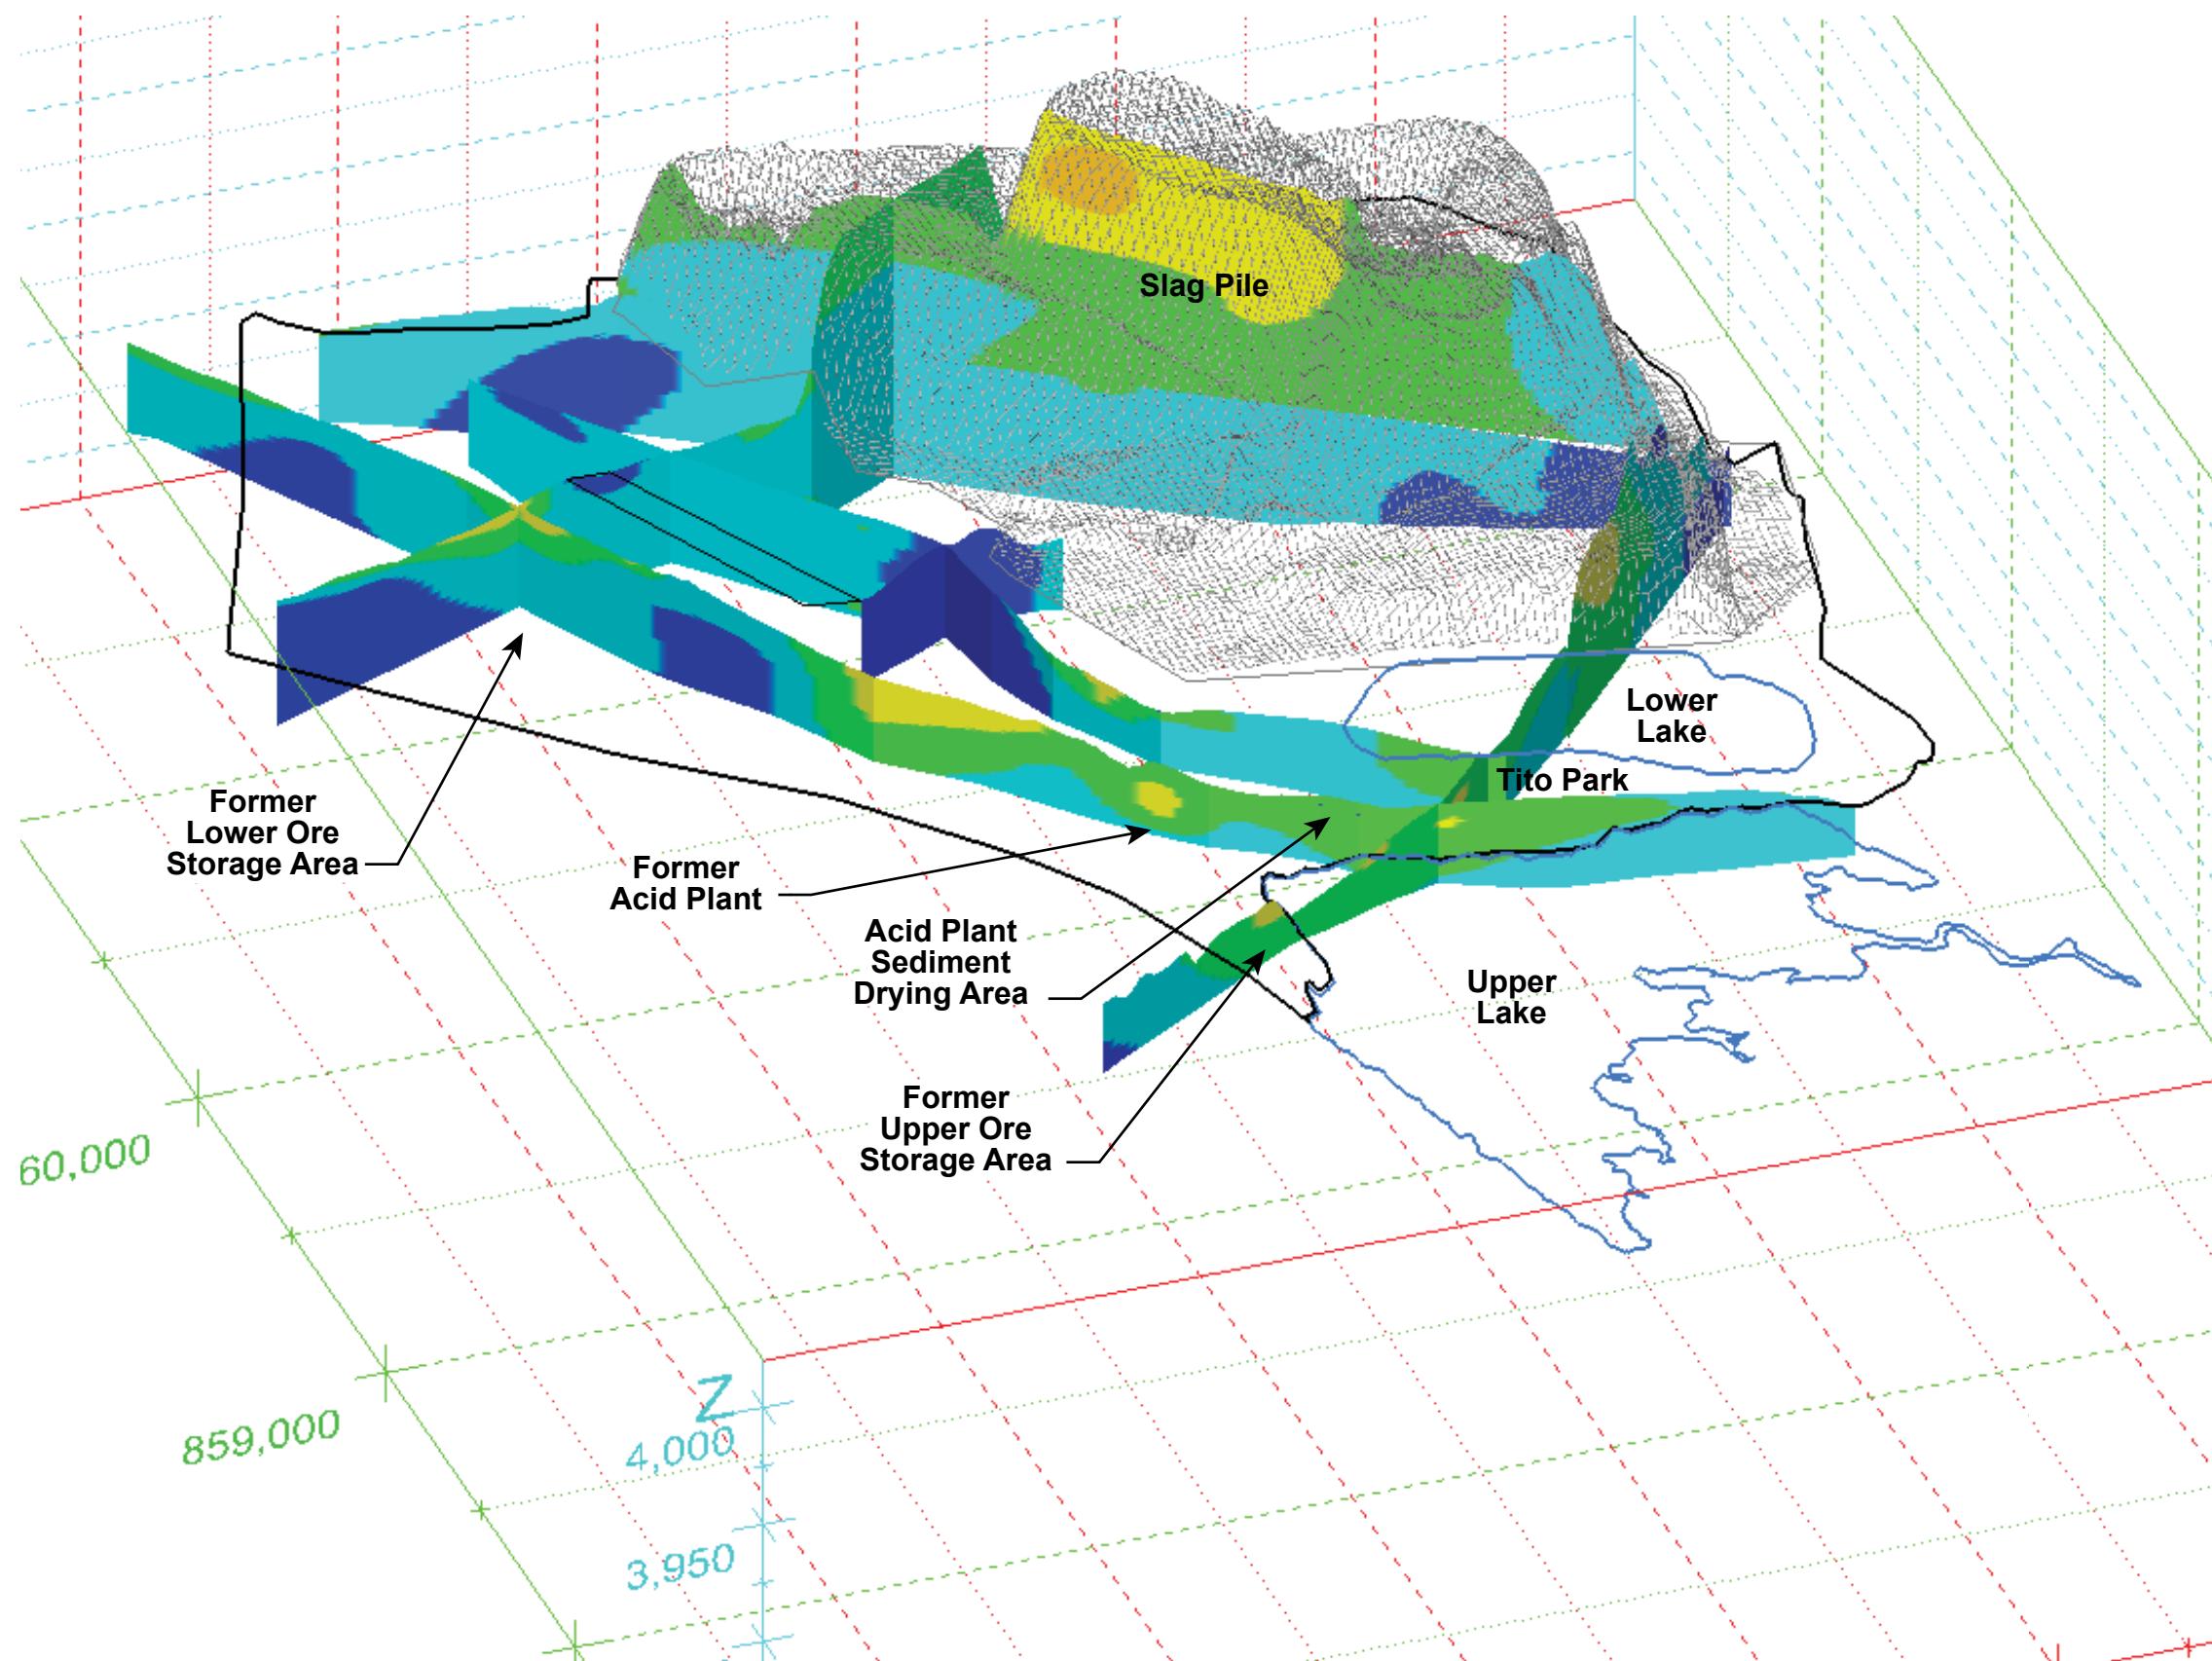
**Figure 3-15**  
**Selenium Contamination in Soil – Surface to Top of Tertiary Ash/Clay Layer**  
Former ASARCO East Helena Facility  
Corrective Measures Study Report  
East Helena, Montana

\* Orange indicates highest concentrations of Selenium in soils at the site, followed by yellow and then green.  
Blues are considered background concentrations.

This figure shows the 3-Dimensional "cross sections" through the site to illustrate depth and location of impacts to site soils.
