Figures

**Figure 1-1**  
**Geographic Boundaries of the CMS**  
Former ASARCO East Helena Facility  
Corrective Measures Study Report  
East Helena, Montana

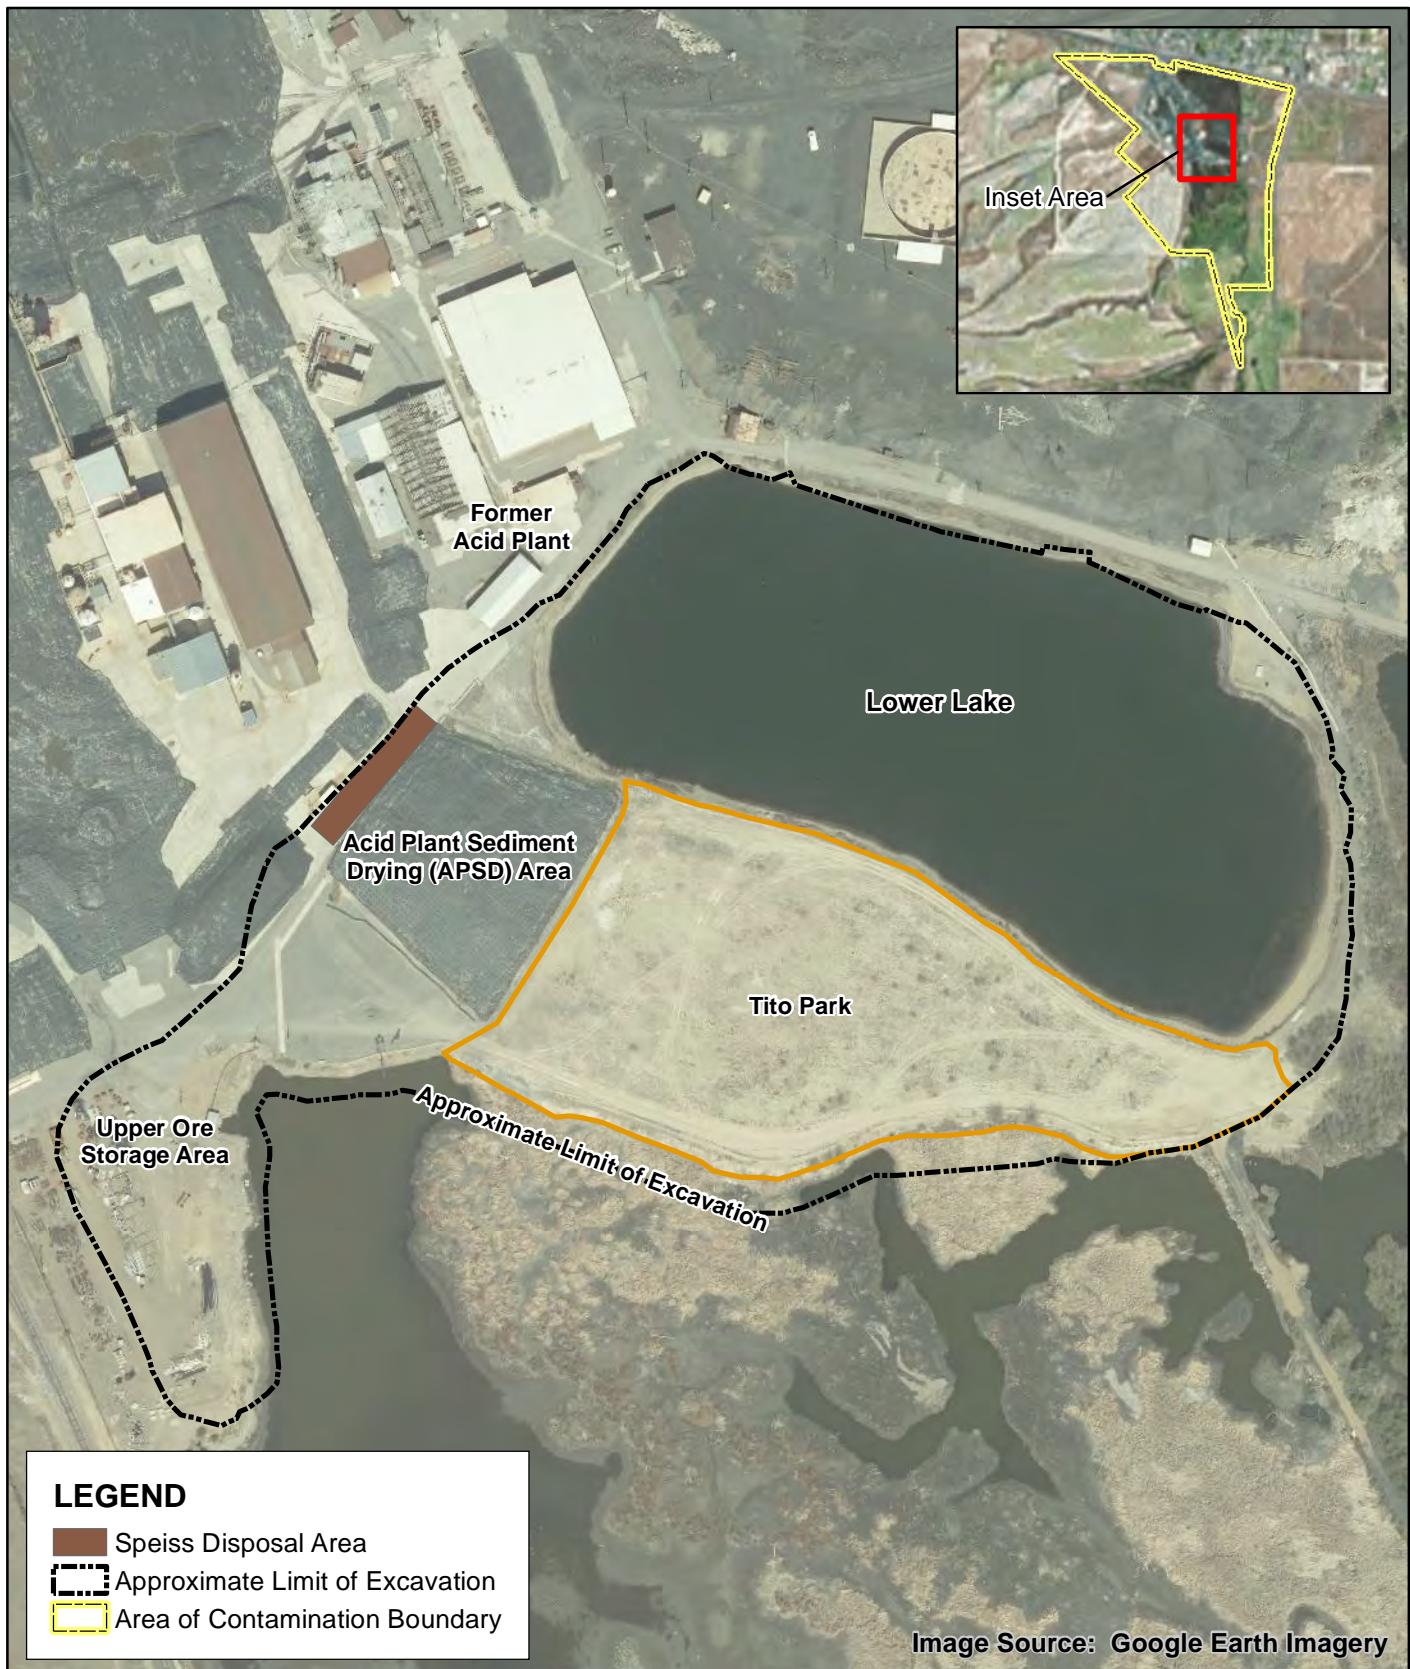
Notes:

- Demolition of all site structures was conducted as part of the construction of the ET Cover System IM
- ET = Evapotranspiration
- IM = Interim Measure

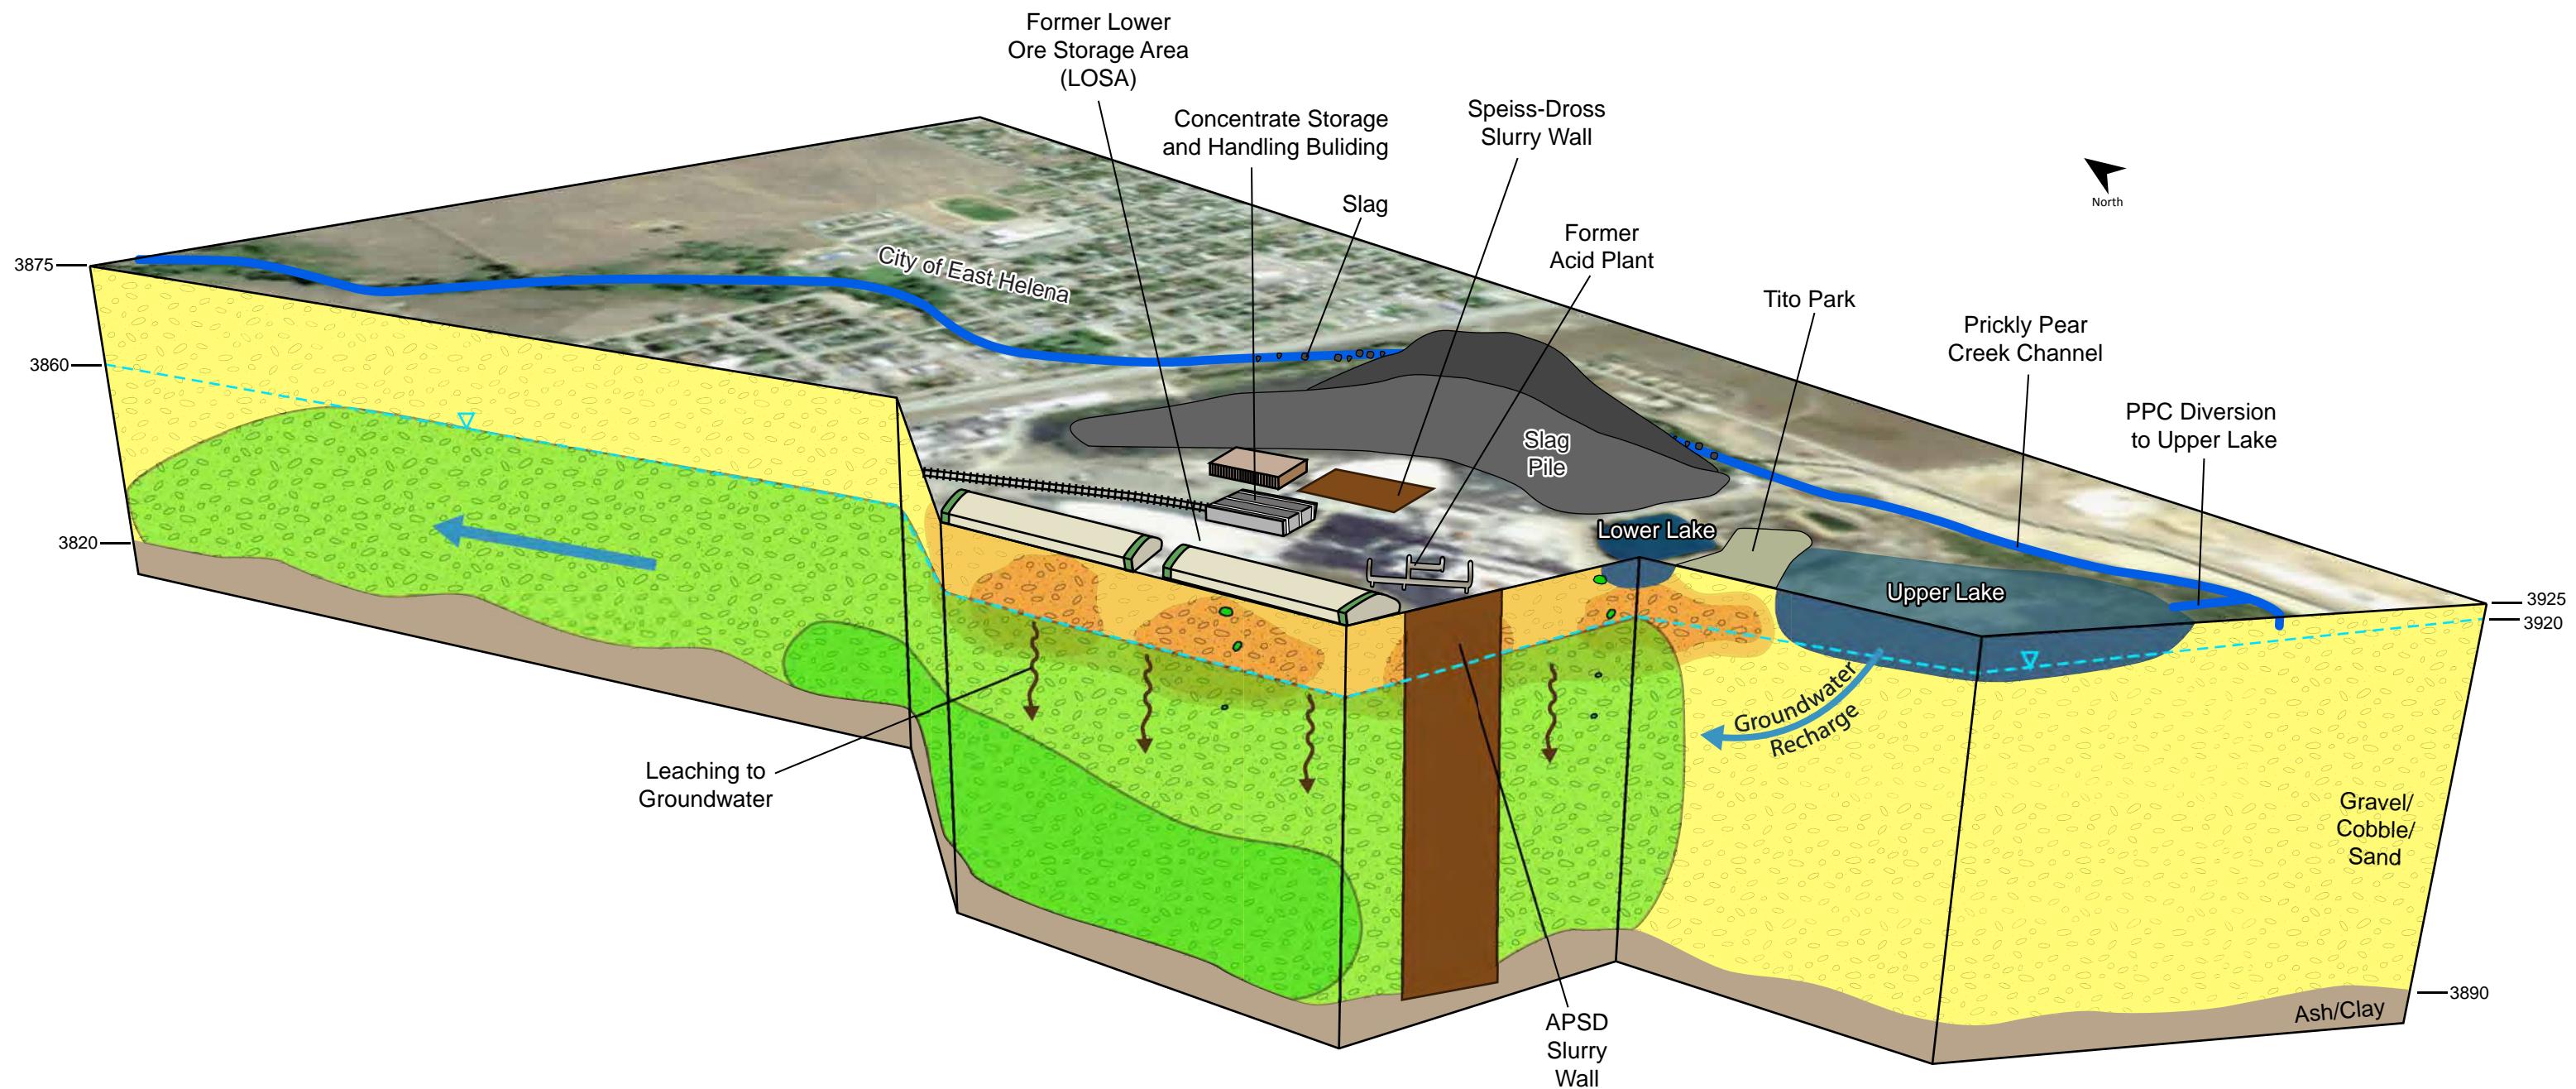
**Figure 3-24**  
**Conceptual Model of Post-Operational Smelter**  
*Former ASARCO East Helena Facility Corrective Measures Study Report*

NOTE:  
Darker colors represent higher contaminant concentrations.  
APSD - Acid plant sediment drying bed

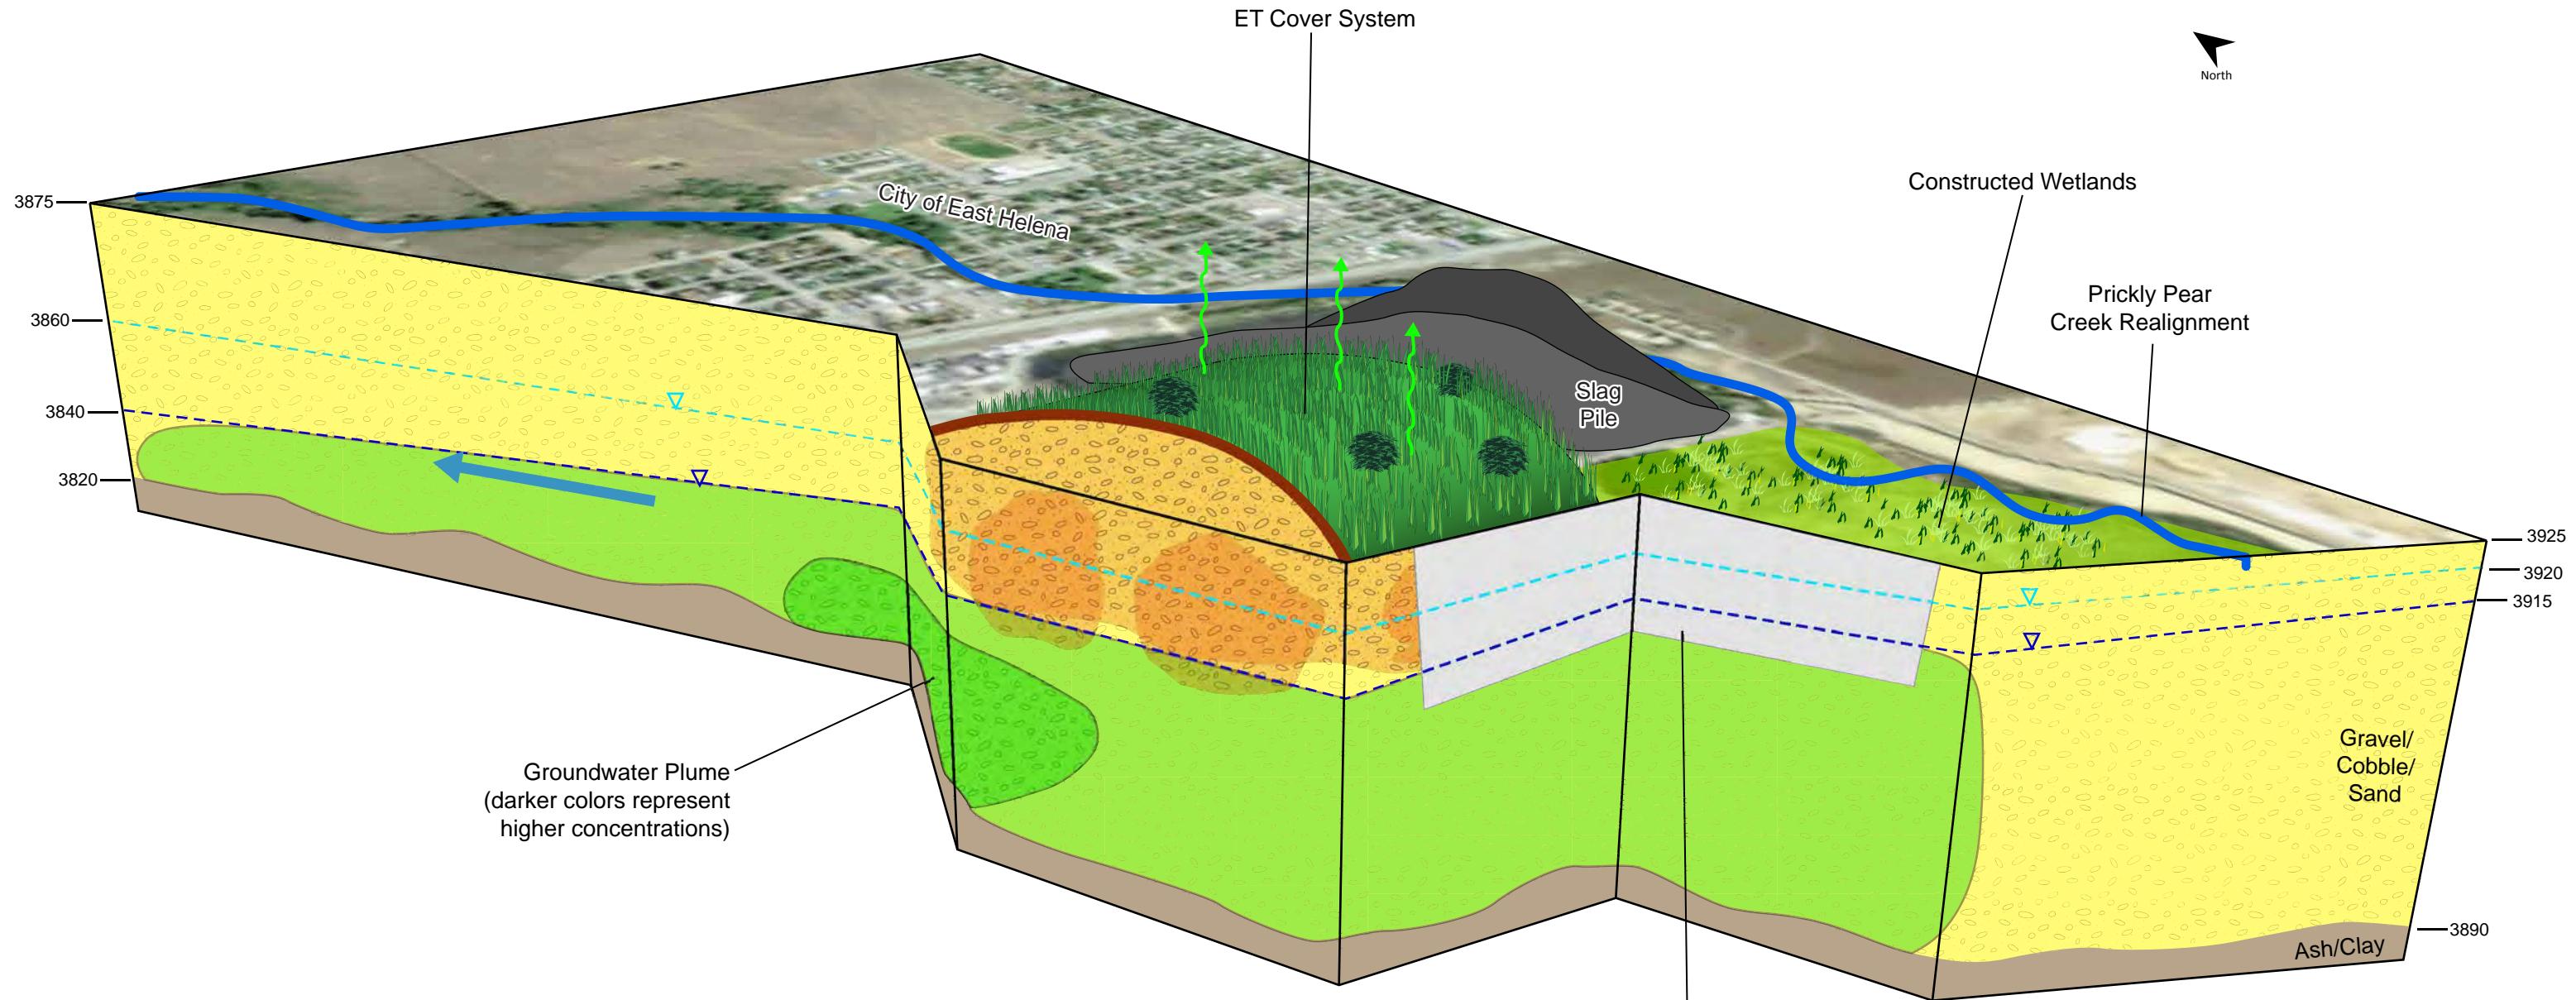
**Figure 3-25**  
**Conceptual Model of Current Conditions**  
Former ASARCO East Helena Facility Corrective Measures Study Report

**NOTE:**  
Darker colors represent higher contaminant concentrations.  
TPA = Tito Park area  
APSD = Acid plant settling drying bed  
AP - Acid plant  
ET - evapotranspiration  
SPHC IM - South Plant Hydraulic Control Interim Measure

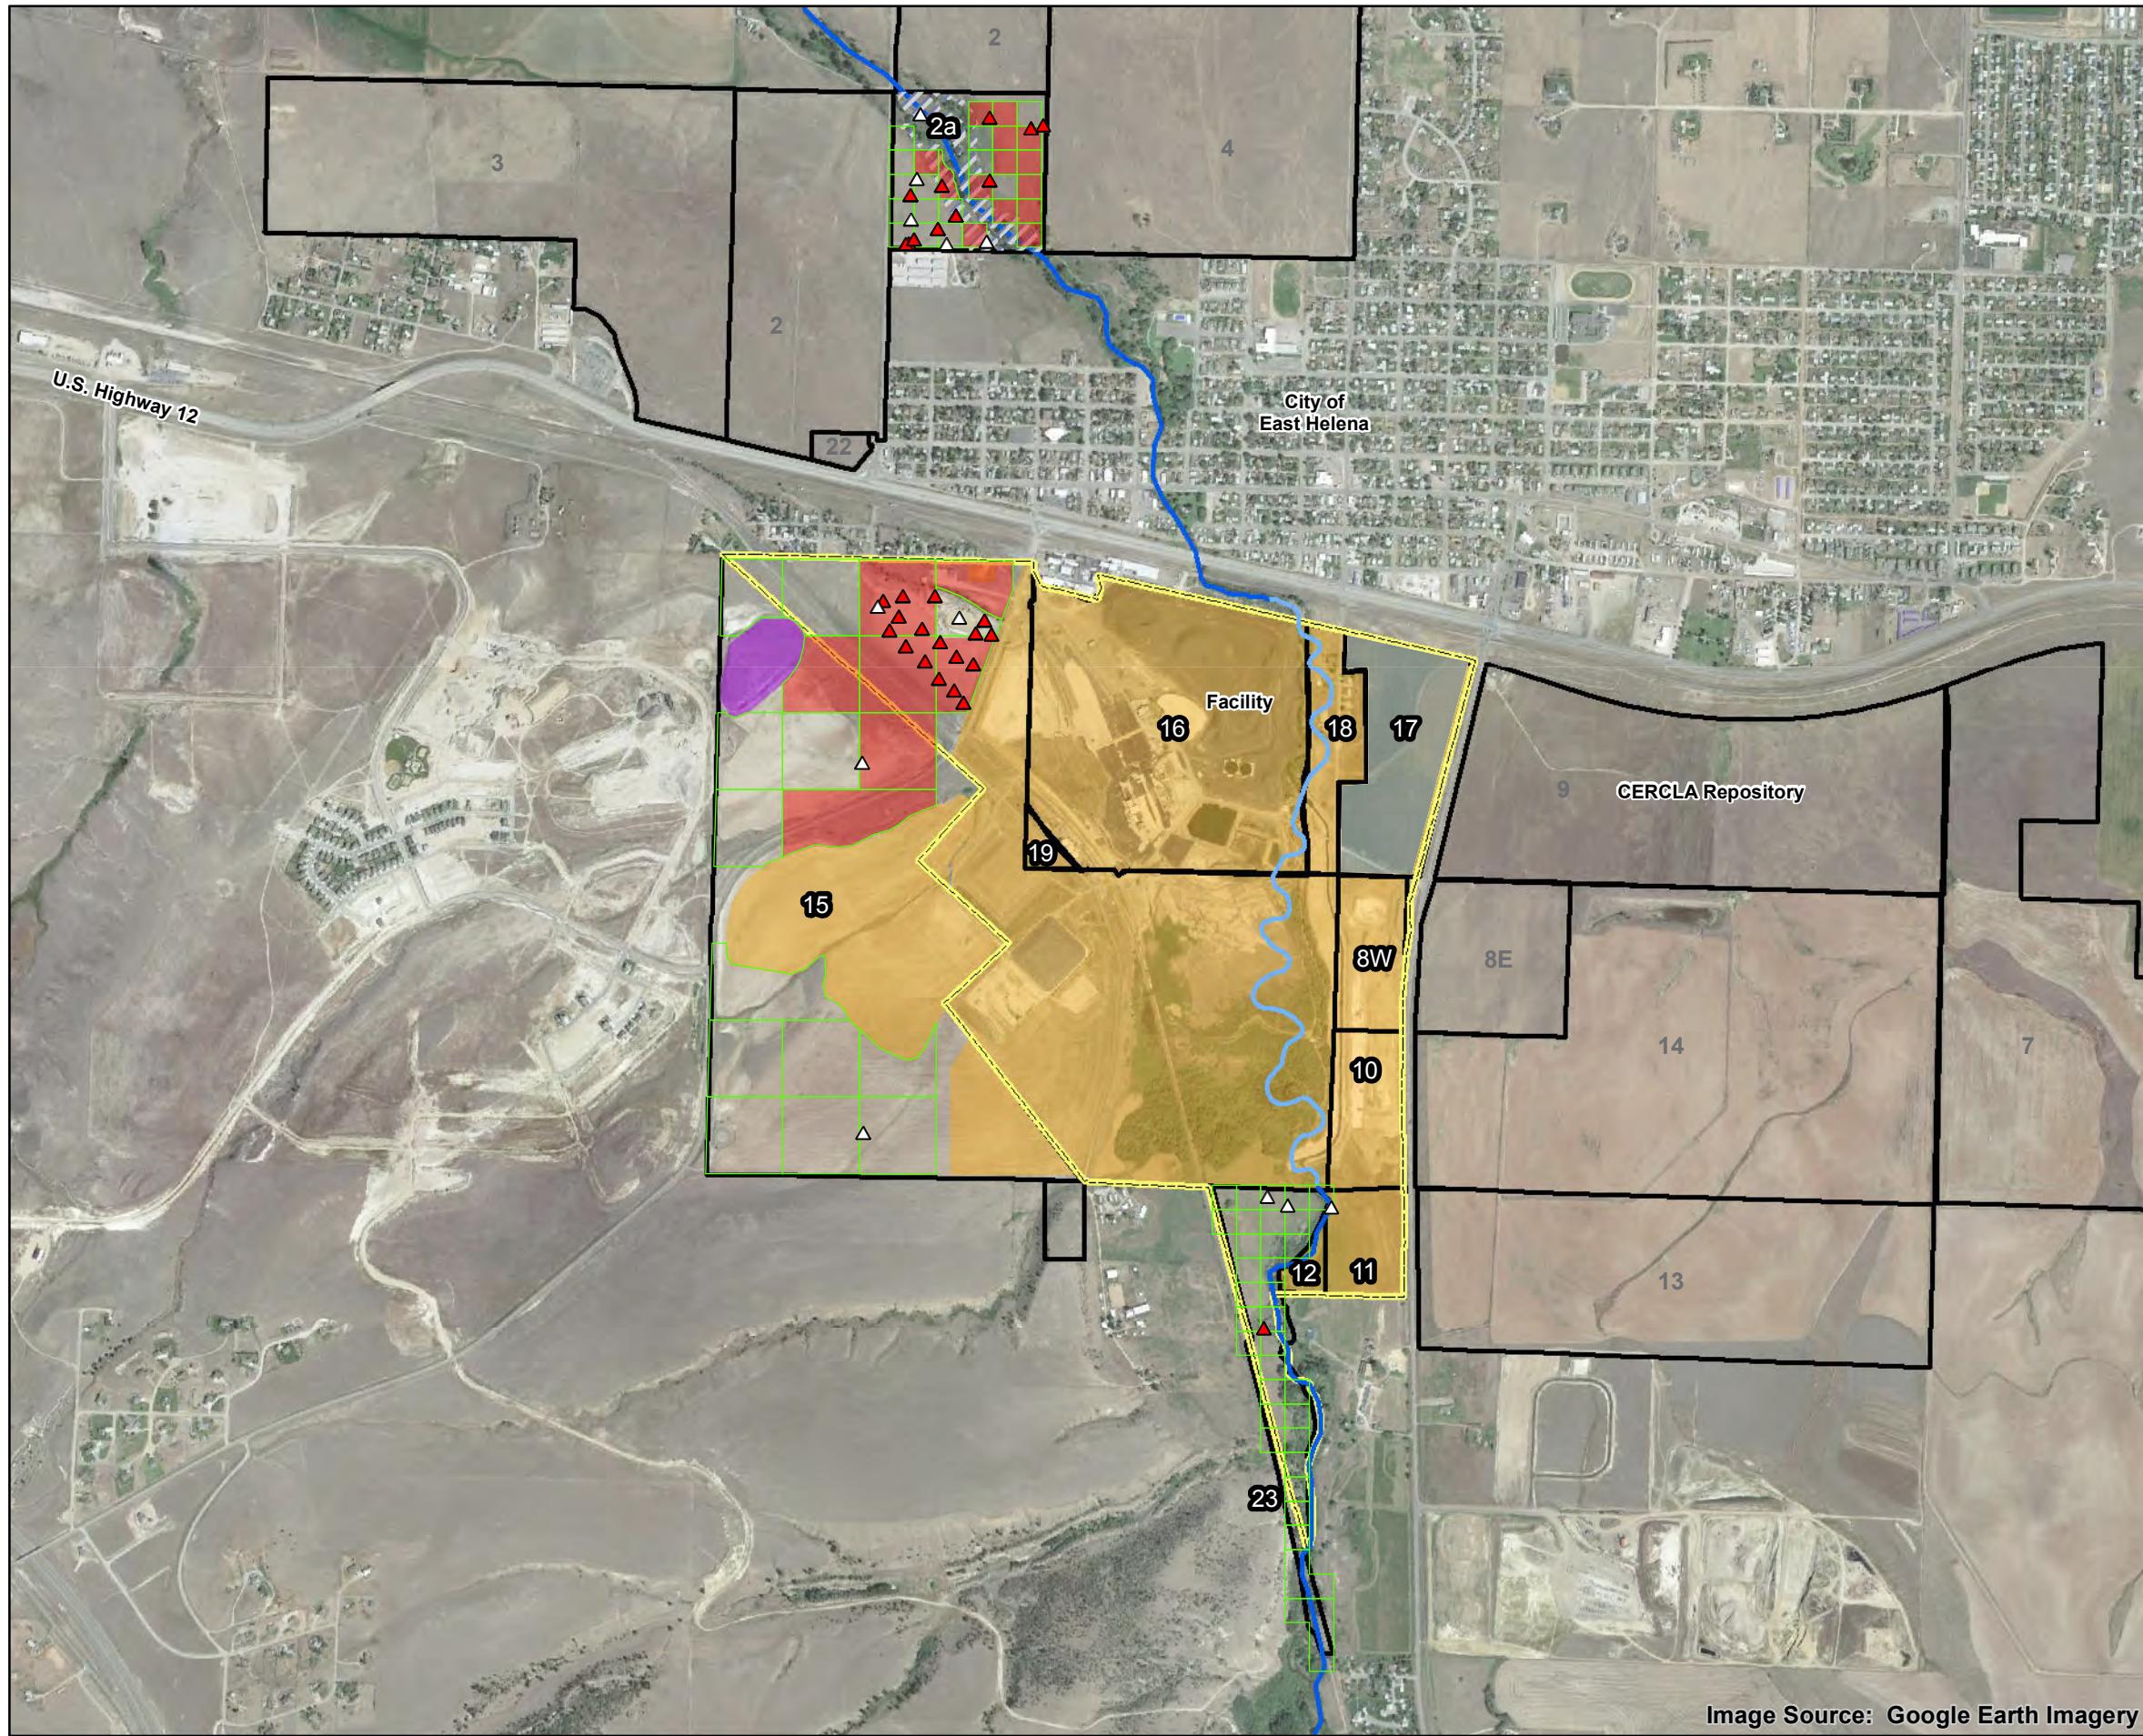
**Figure 3-29**  
**Comparison of Surface Soil Results to Ecological Media Cleanup Standard**  
Former ASARCO East Helena Facility  
Corrective Measures Study Report  
East Helena, Montana

1. Red sample location exceeds ecological media cleanup standard for lead of 650 mg/kg
2. DU = decision unit
3. RFI = Resource Conservation and Recovery Act Facility Investigation
4. CERCLA = Comprehensive Environmental Response, Compensation, and Liability Act of 1980
5. IM = Interim Measure
6. mg/kg = milligrams per kilogram
7. CMS = corrective measures study

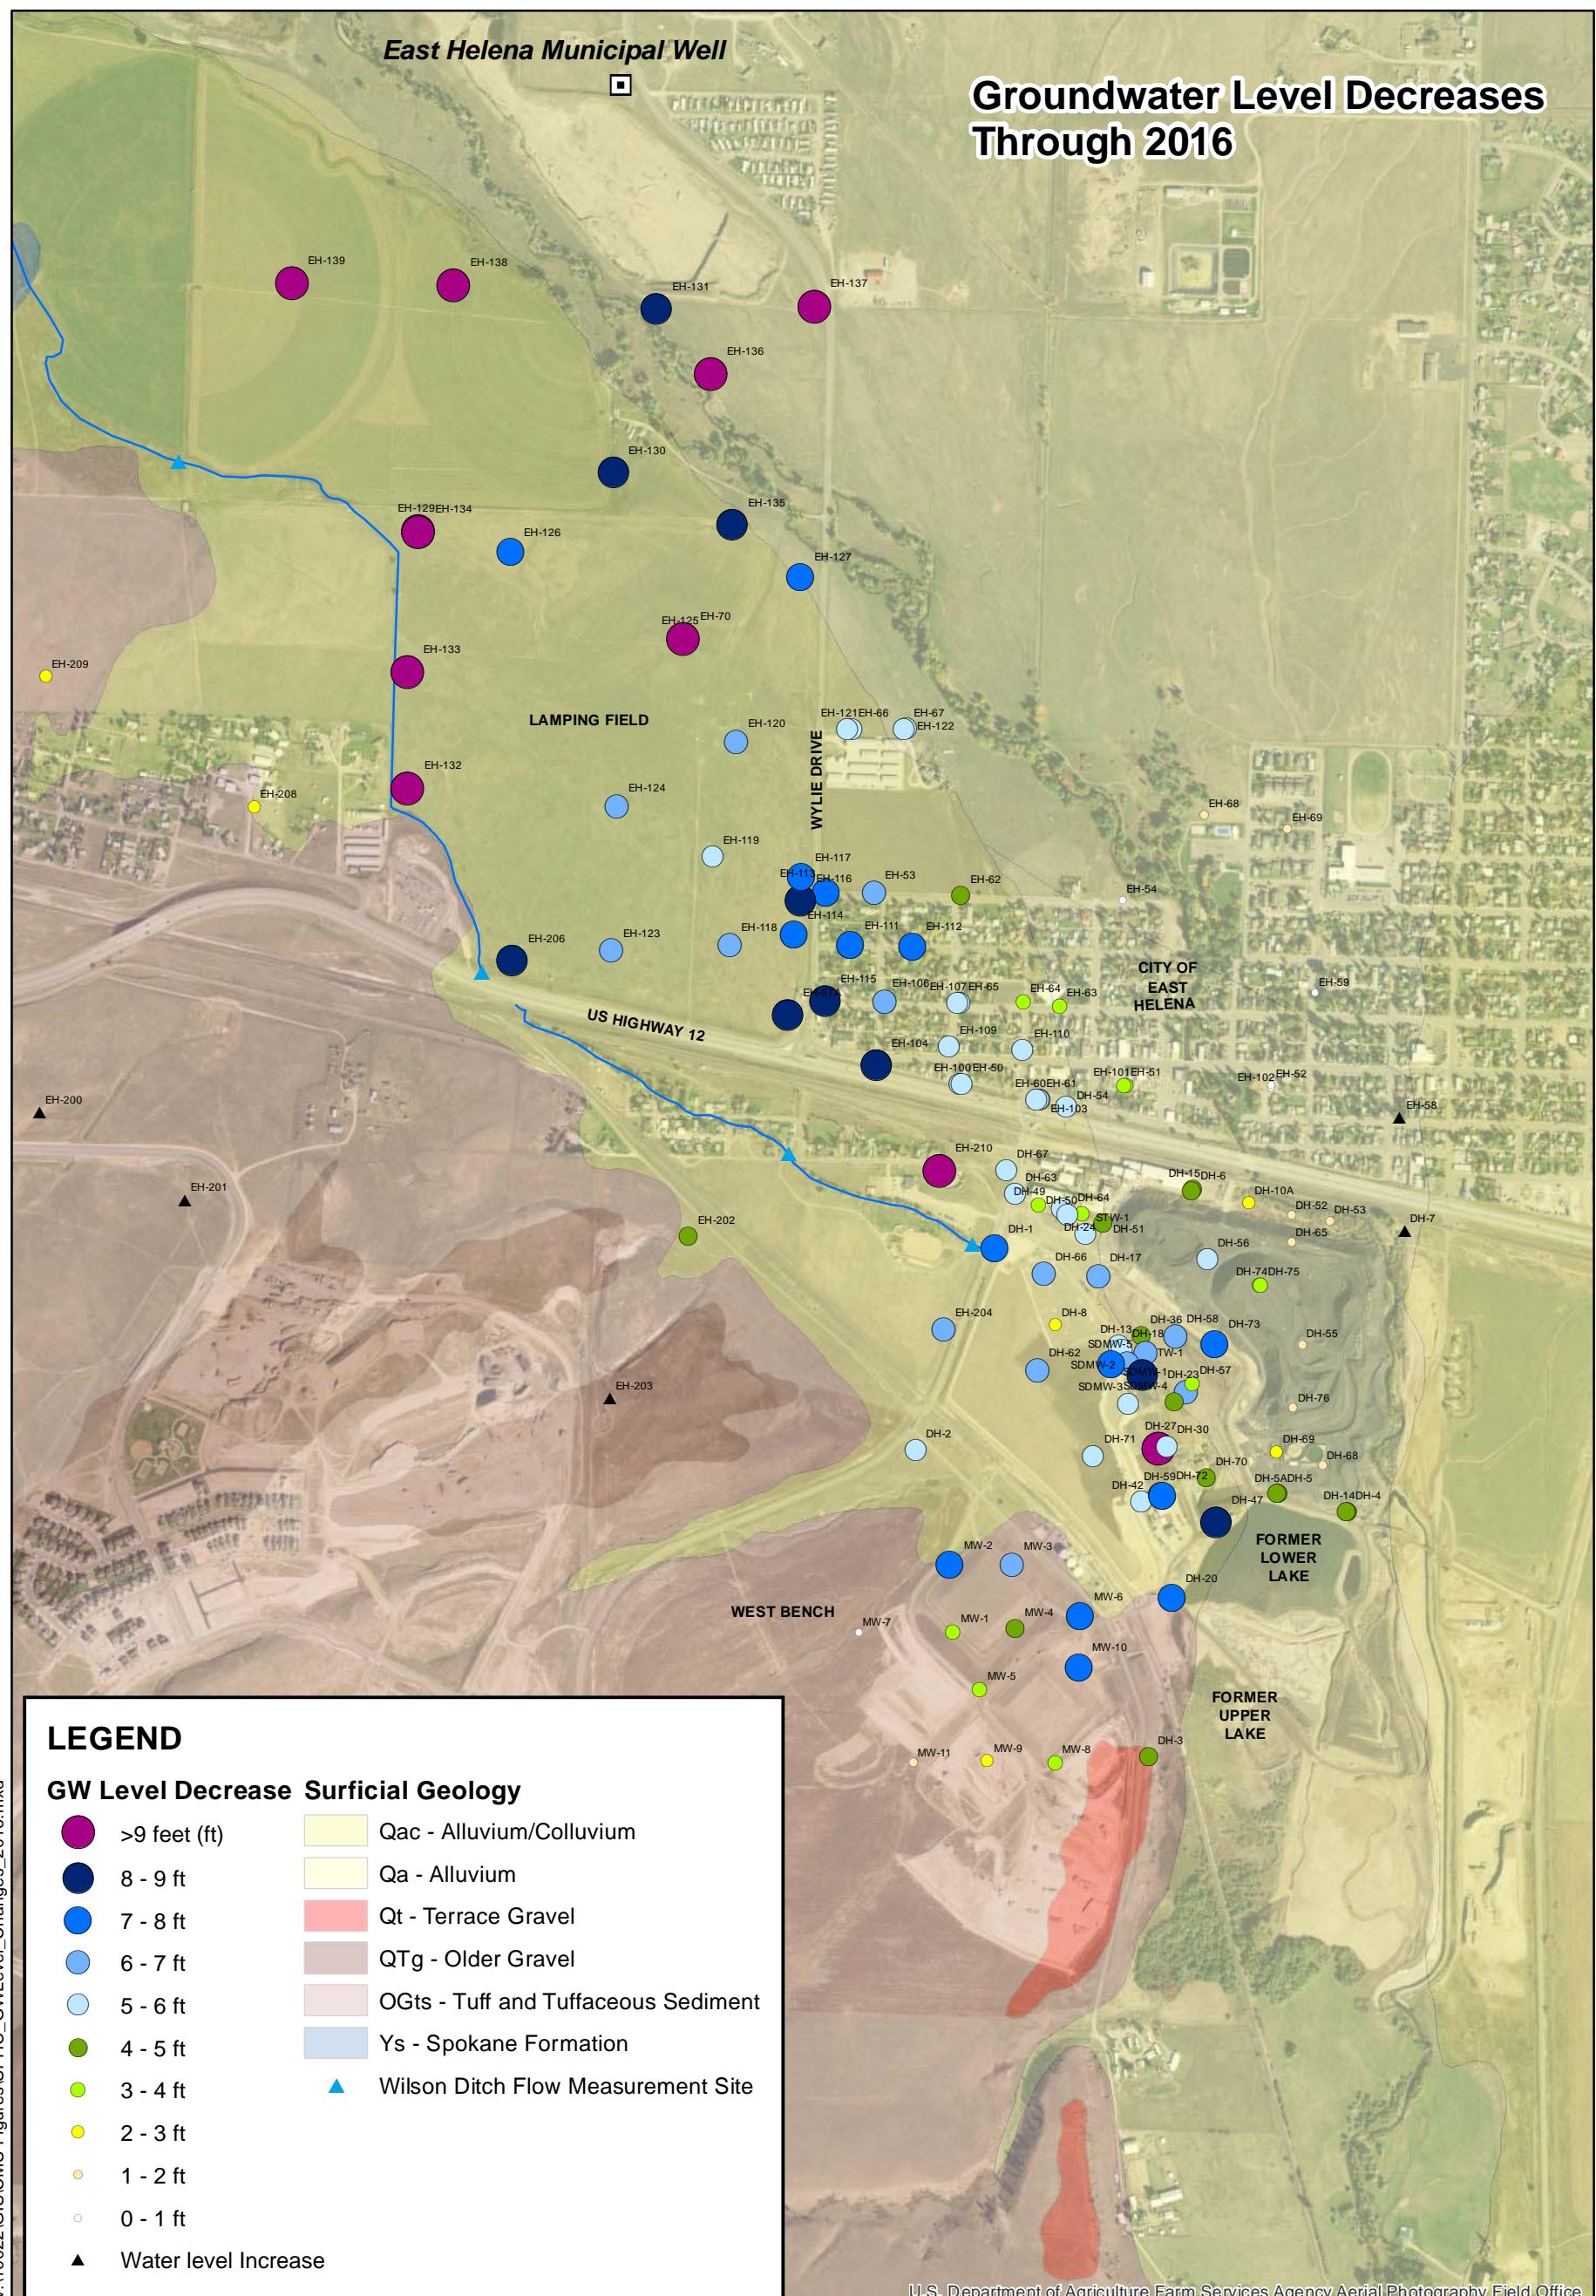
**Figure 3-32**  
**Relative Changes in Water Levels**  
Former ASARCO East Helena Facility  
Corrective Measures Study Report  
East Helena, Montana

NOTE: Groundwater level changes shown were calculated as the difference between 2002 -2010 average elevations and 2016 average elevations.

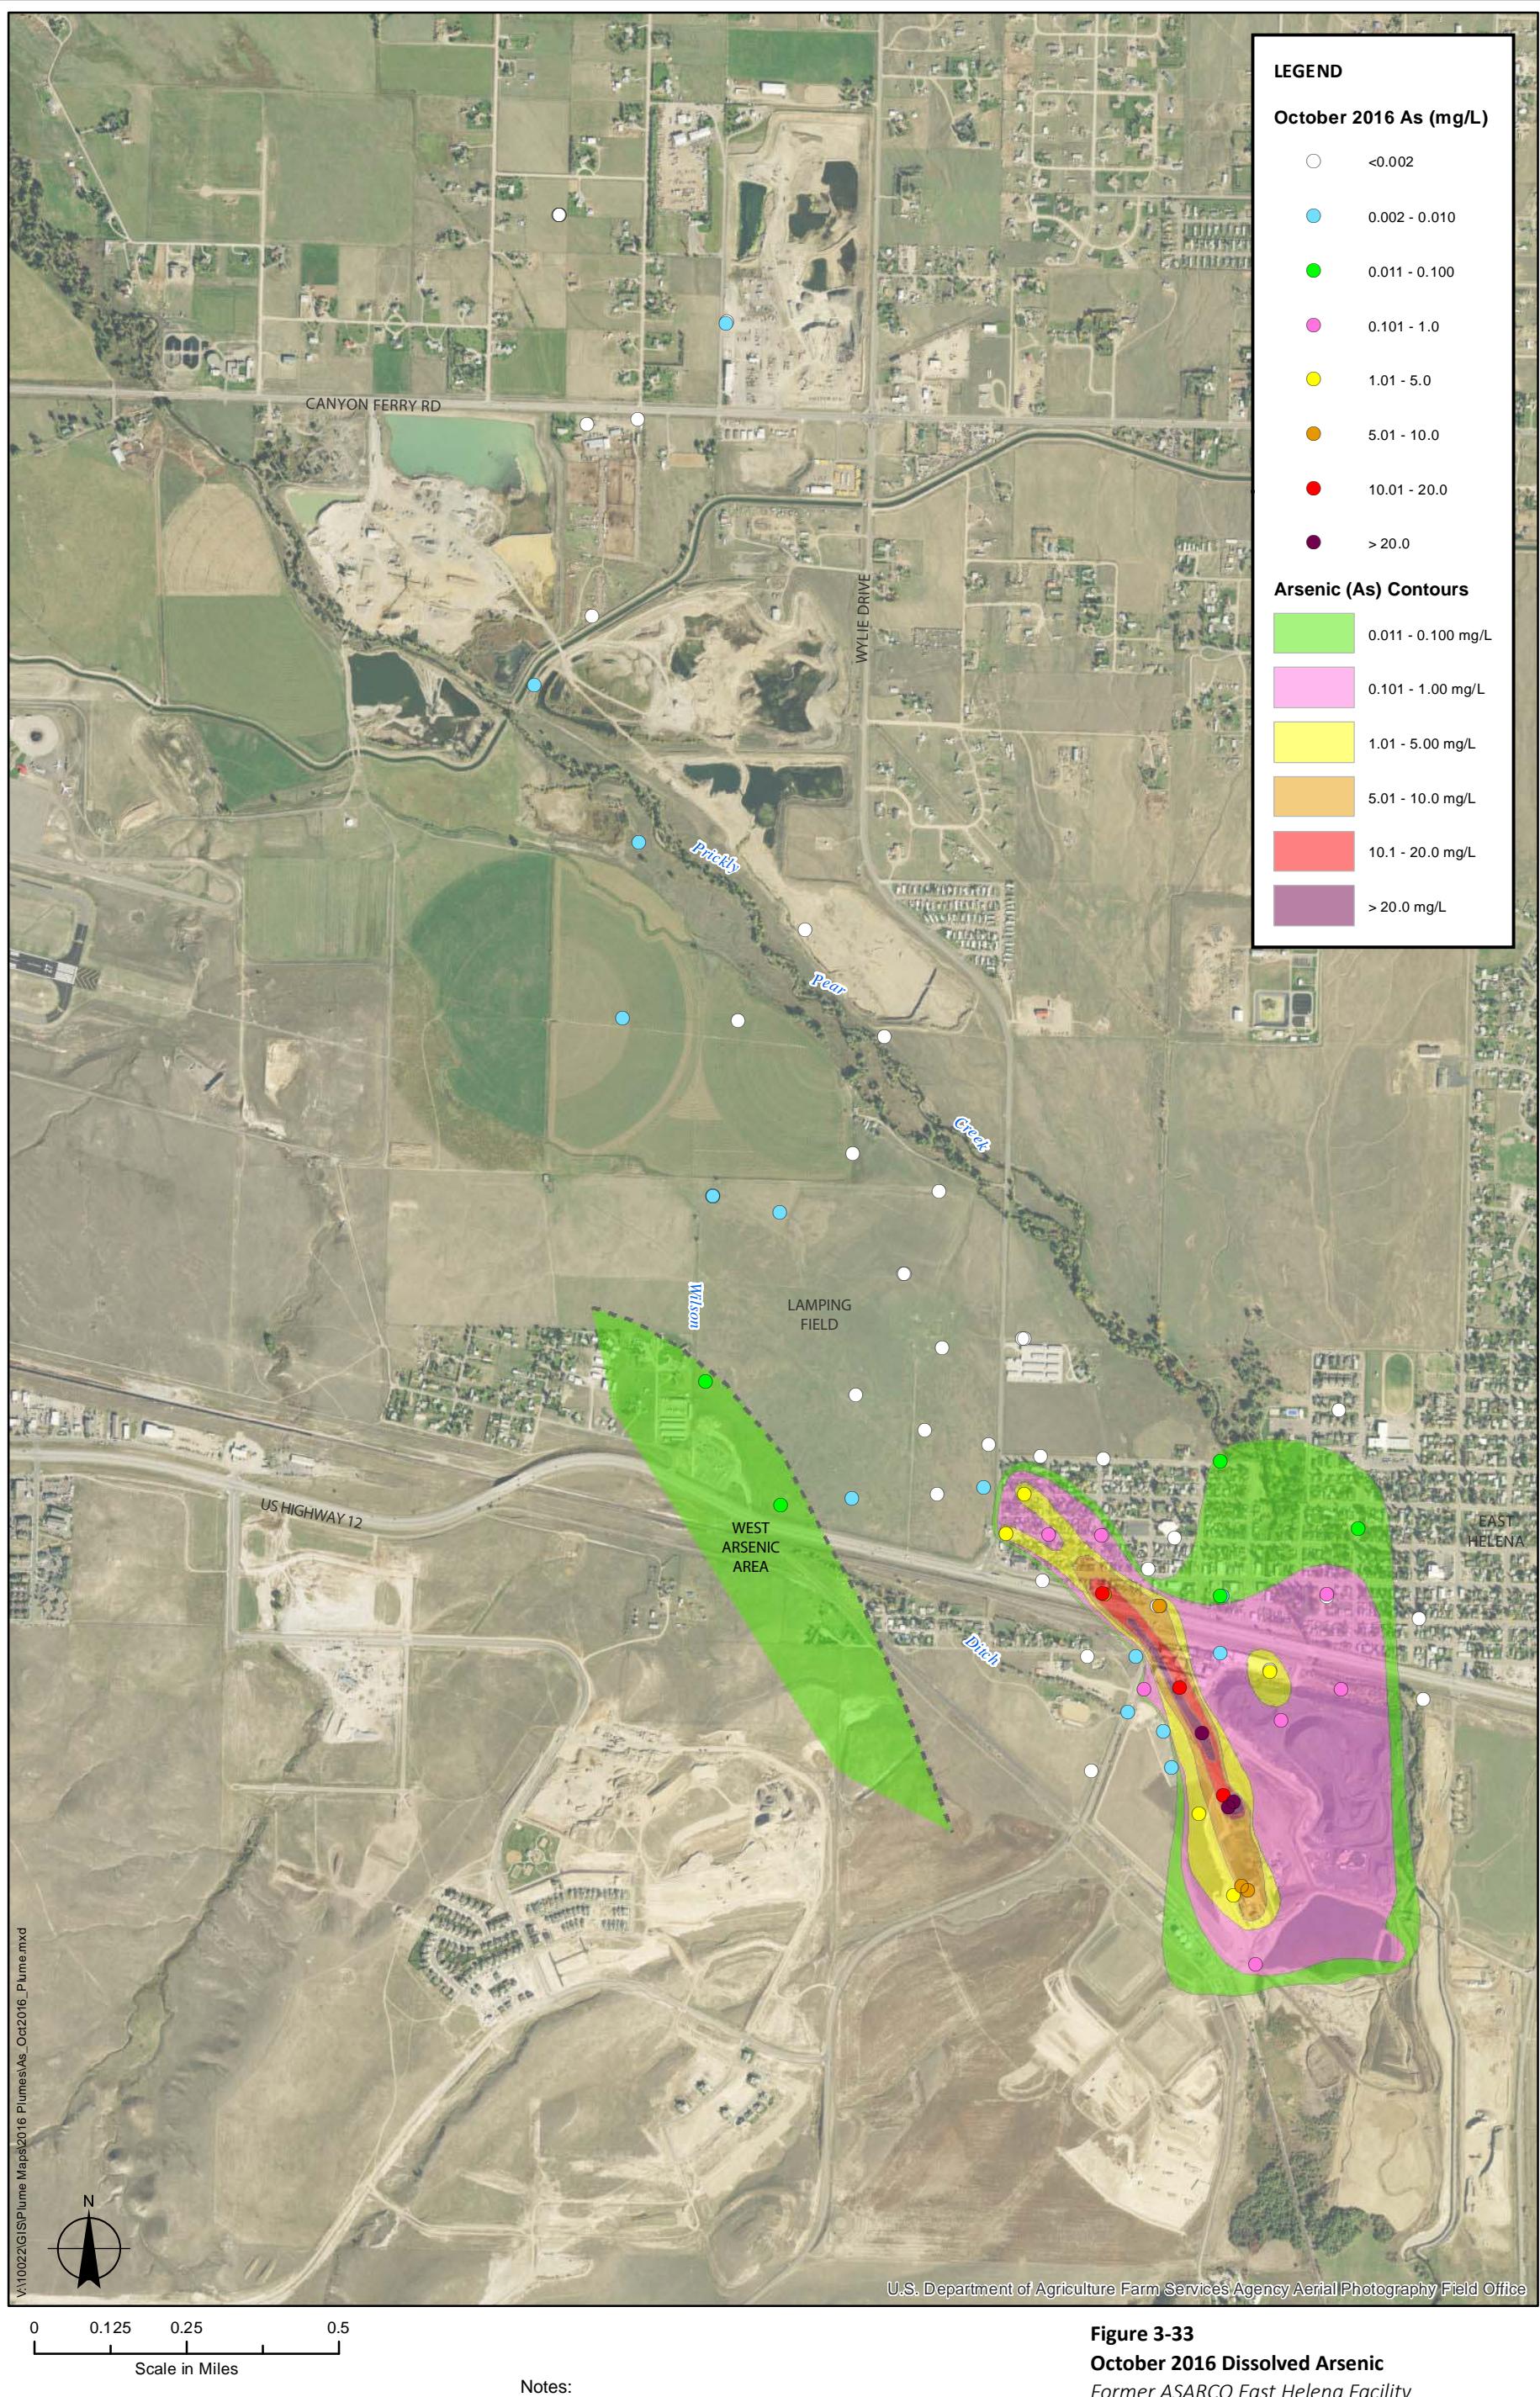
**Figure 3-33**  
**October 2016 Dissolved Arsenic**  
*Former ASARCO East Helena Facility  
 Corrective Measures Study Report  
 East Helena, Montana*

**Notes:**  
 1. mg/L - milligrams per liter  
 2. West Arsenic Area - Occurs primarily from groundwater interaction with naturally-occurring arsenic-bearing soil and is not facility related.

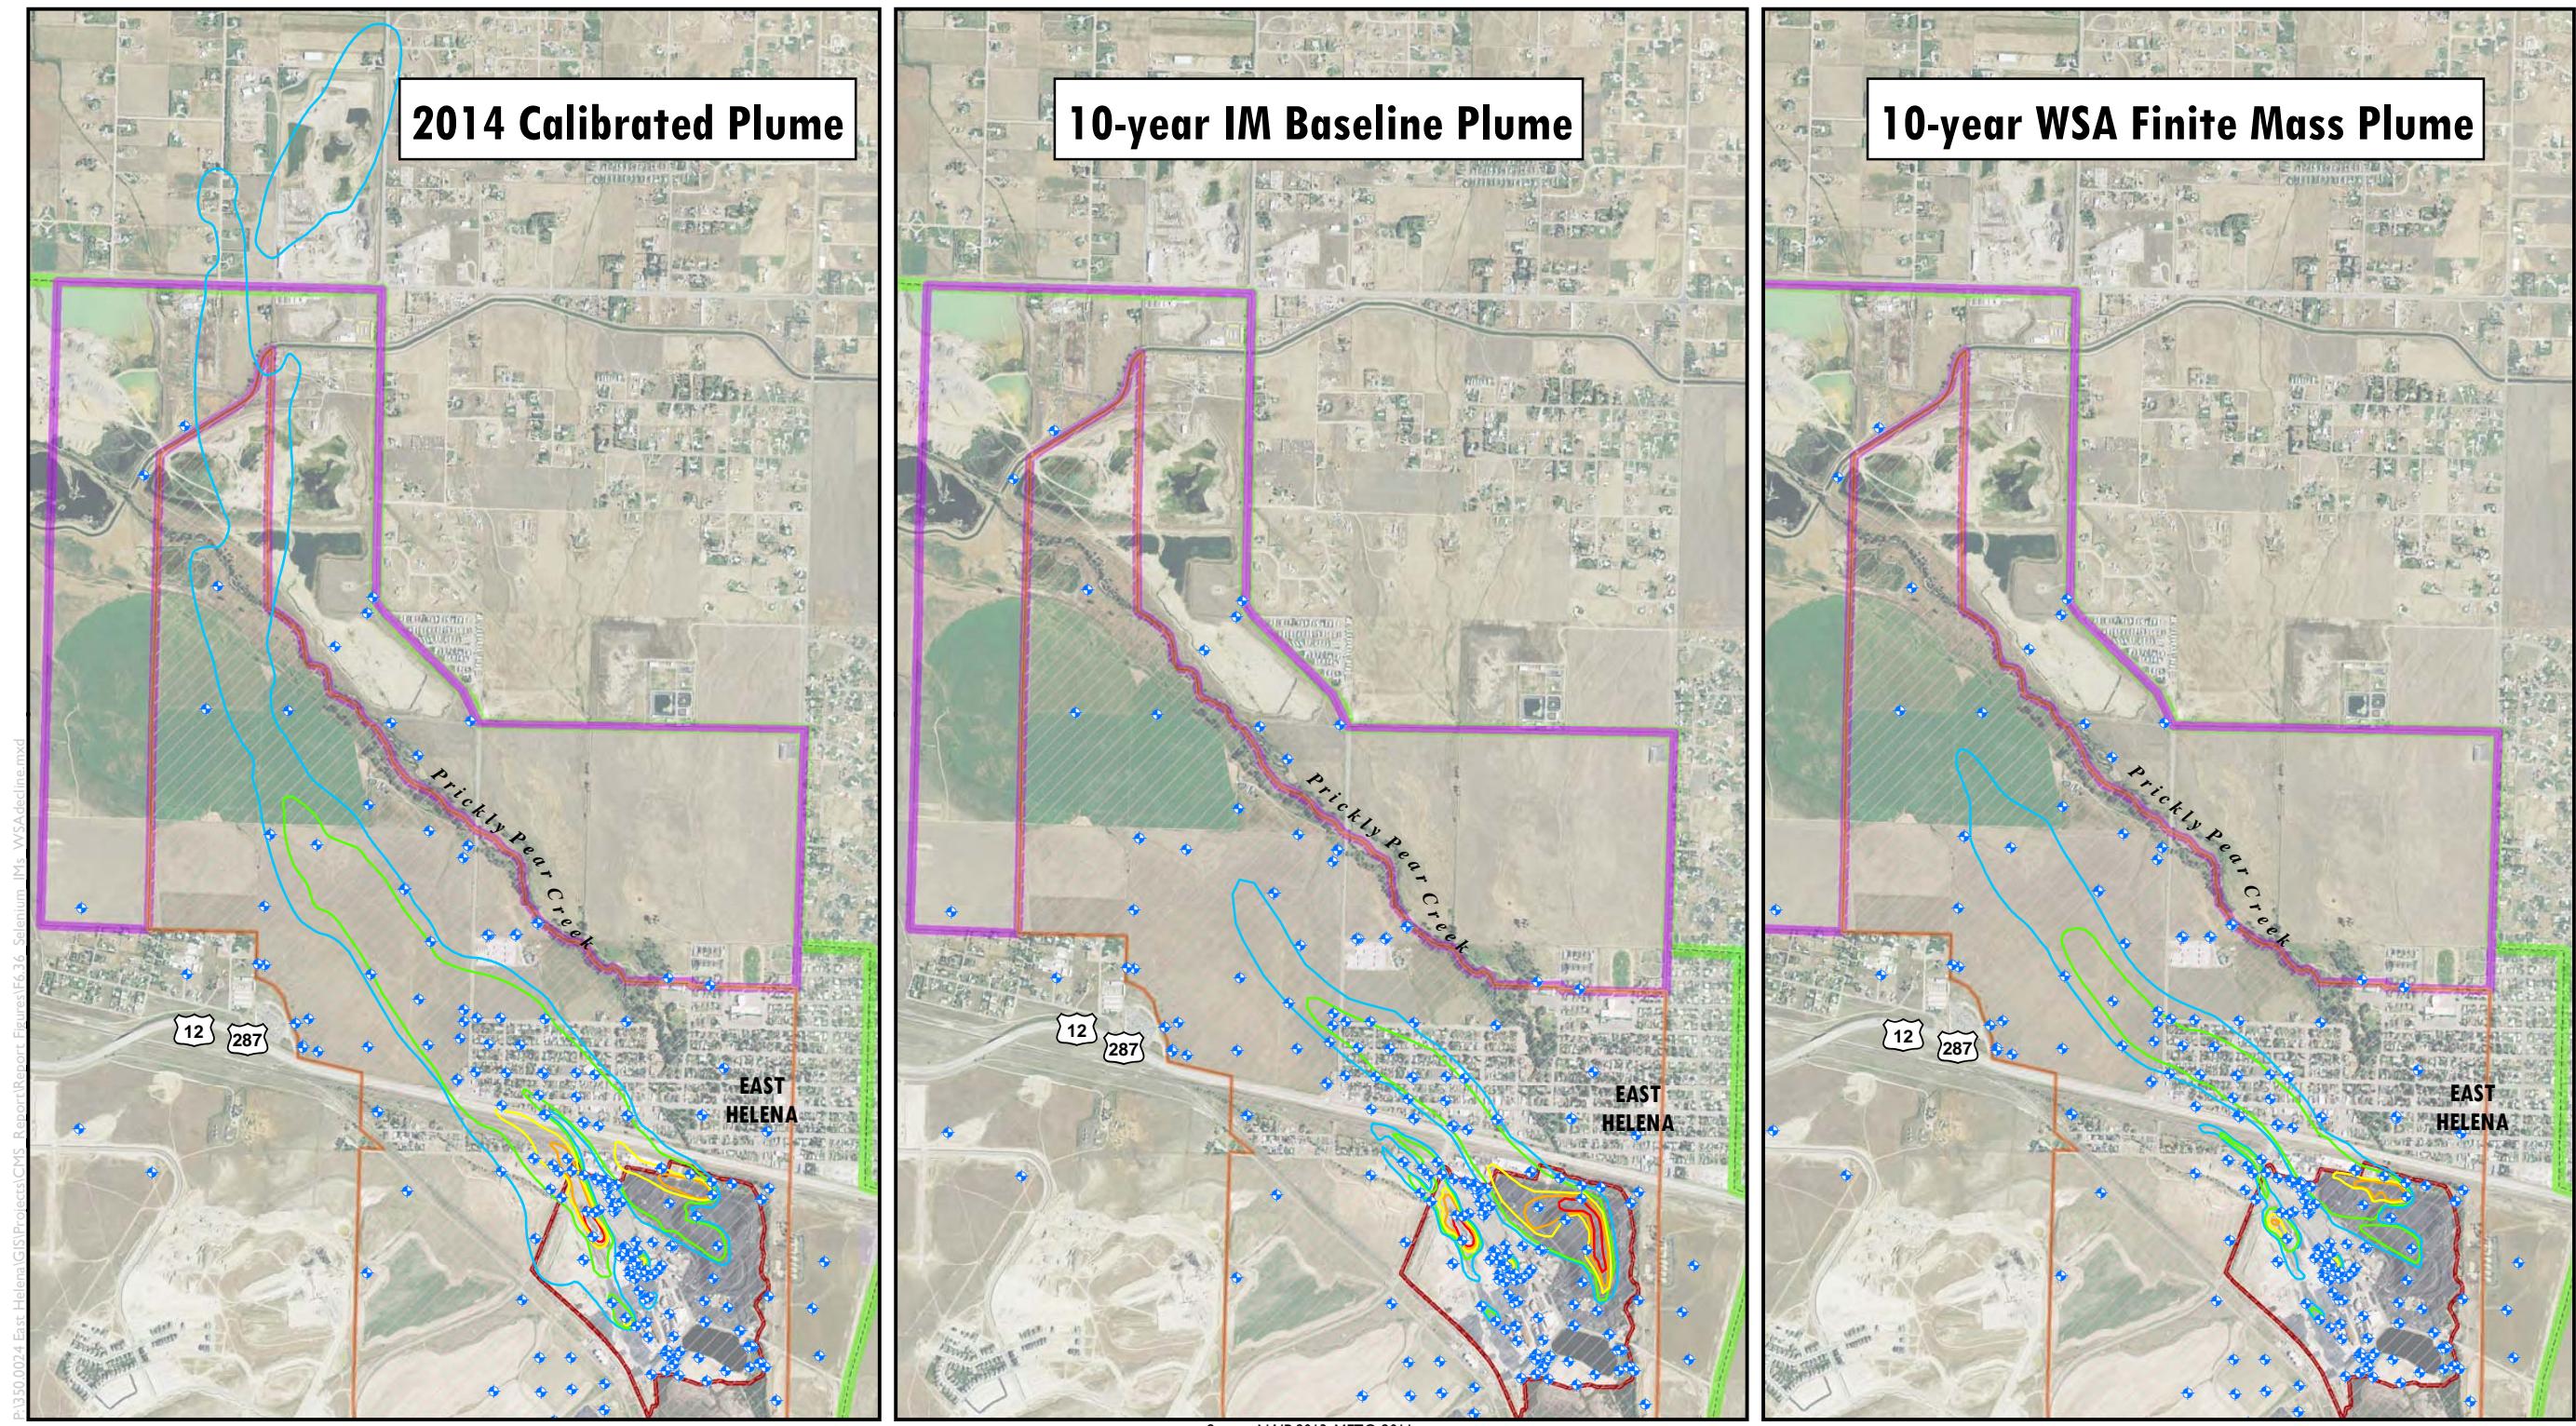
- 1) Simulated plumes represent a composite of model layers 1, 2, 3, and 4.
- 2) Predictive results depict concentrations in stress period 66, after model has reached steady-state.
- 3) mg/L = milligram per liter; CGWA = Controlled Groundwater Area.
- 4) Results are from NewFields (2016a).
- 5) Refer to Appendix B for further details of model operations and predictions
