Figures

**Figure 1-1**  
**Geographic Boundaries of the CMS**  
Former ASARCO East Helena Facility  
Corrective Measures Study Report  
East Helena, Montana

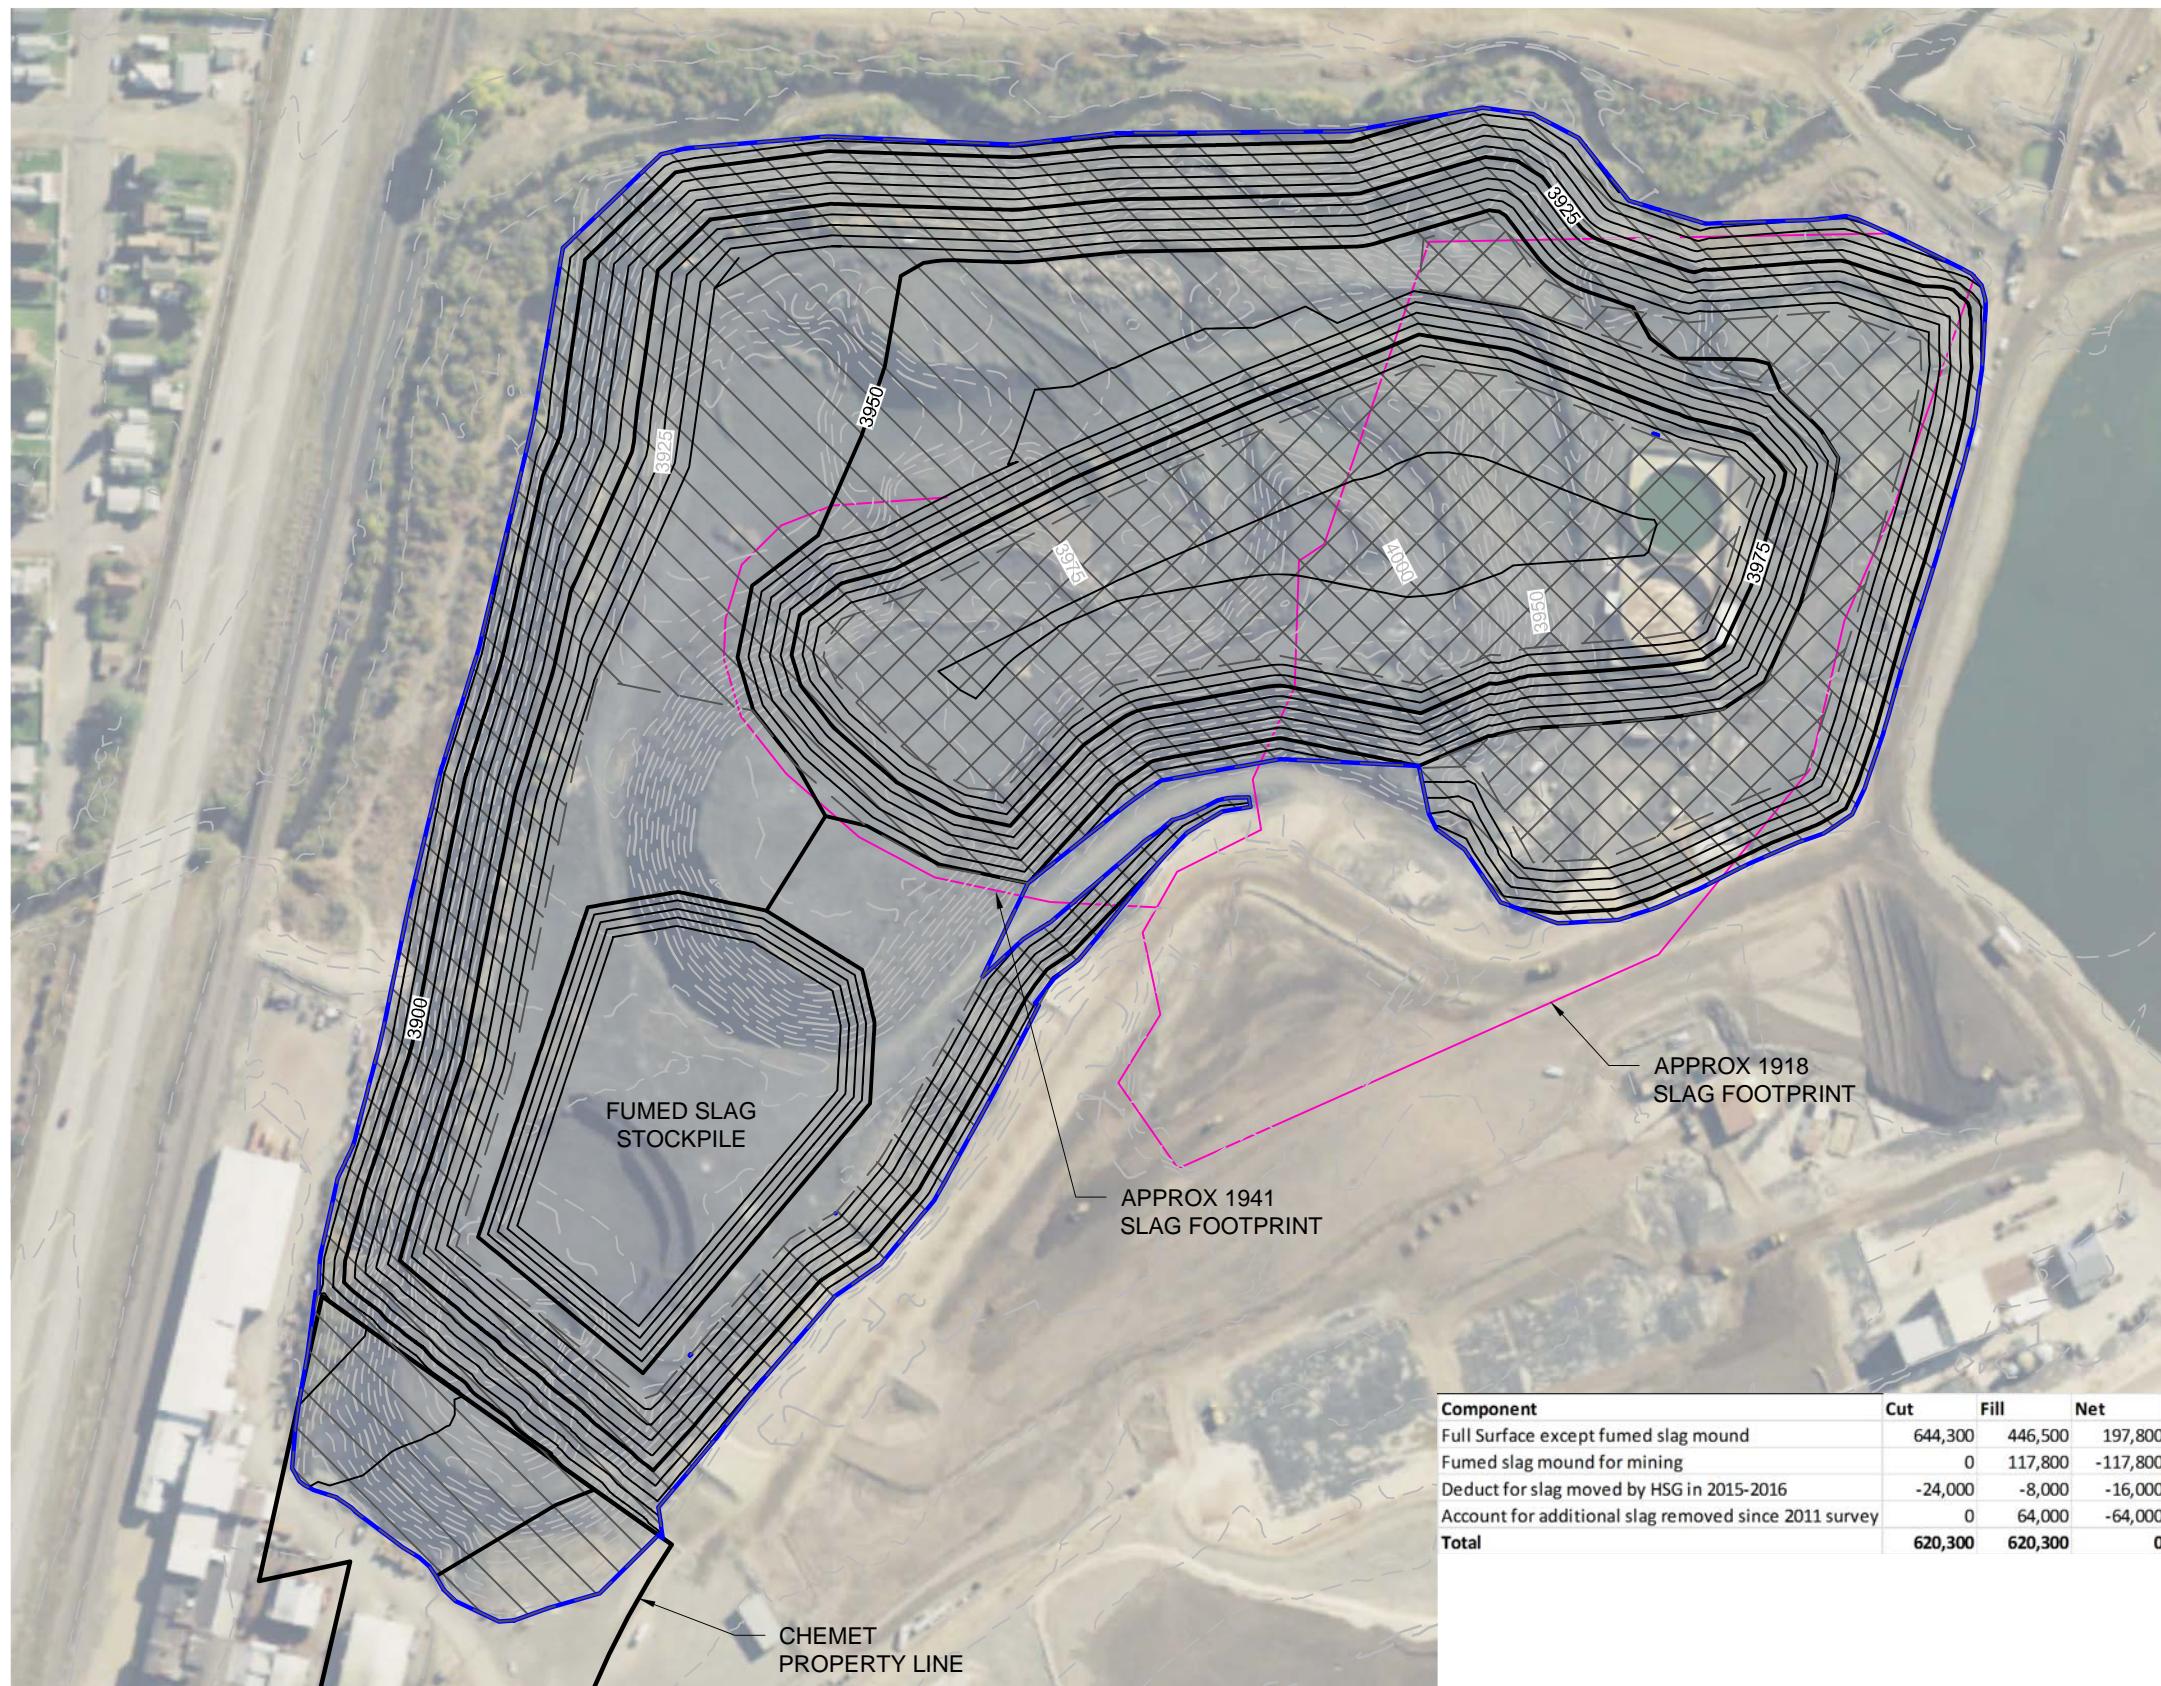
**Figure 5-16**  
**Slag Pile Conceptual Grading Plan - Maximum Alternative Plan View**  
Former ASARCO East Helena Facility  
Corrective Measures Study Report  
East Helena, Montana

SOIL COVER:  
ET COVER SURFACE AREA:  
405,000 SF  
REQD SOIL VOLUME ASSUMING 3-FT ET COVER:  
45,000 CY
