Former ASARCO Smelter East Helena Facility Annual RCRA Corrective Action Update

December 8, 2020

Montana Environmental Trust Group, LLC
Trustee of the Montana Environmental Custodial Trust

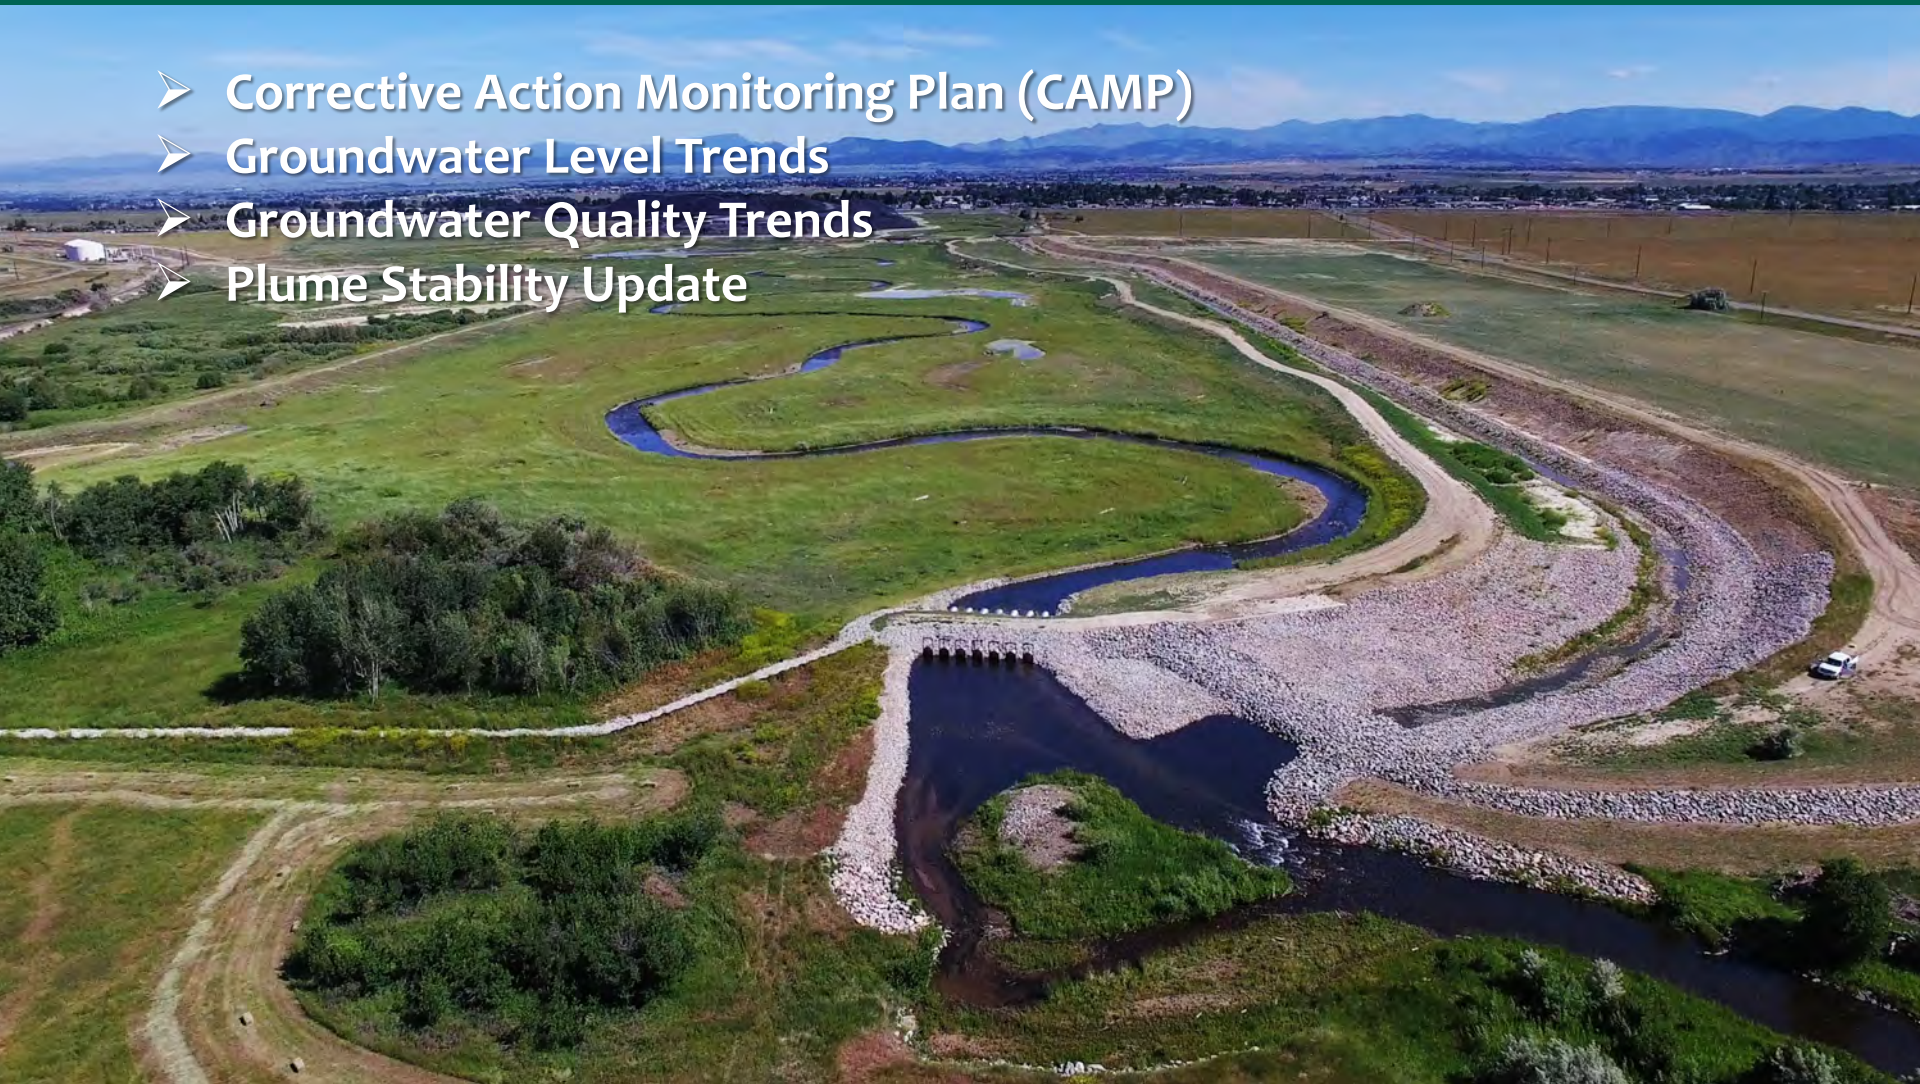
2019/2020 Groundwater Monitoring Results

- Corrective Action Monitoring Plan (CAMP)
- Groundwater Level Trends
- Groundwater Quality Trends
- Plume Stability Update

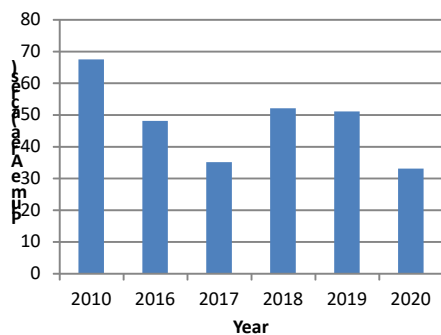
Plant Site Selenium Plume Area Trend

Year	Planar Area (acres)	Average Concentration (mg/L)
2010	67	0.451
2016	48	0.270
2017	35	0.230
2018	52	0.340
2019	51	0.240
2020	33	0.220

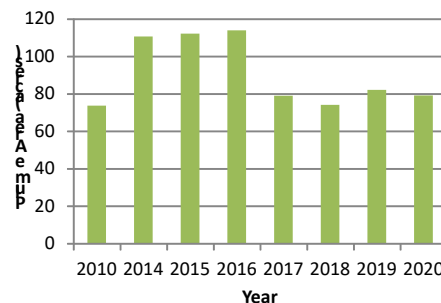
Downgradient Selenium Plume Area Trend

Year	Planar Area (acres)	Average Concentration (mg/L)
2010	74	0.112
2014	111	0.123
2015	112	0.121
2016	114	0.136
2017	79	0.108
2018	74	0.078
2019	82	0.088
2020	79	0.086

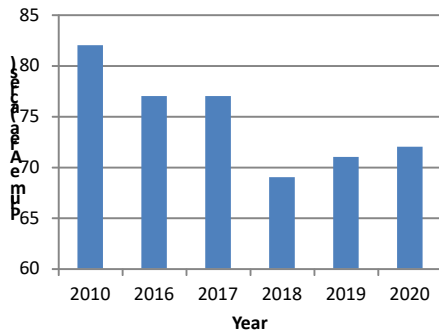
Plant Site Arsenic Plume Area Trend

Year	Planar Area (acres)	Average Concentration (mg/L)
2010	82	2.25
2016	77	1.29
2017	77	1.19
2018	69	0.94
2019	71	1.02
2020	72	1.04

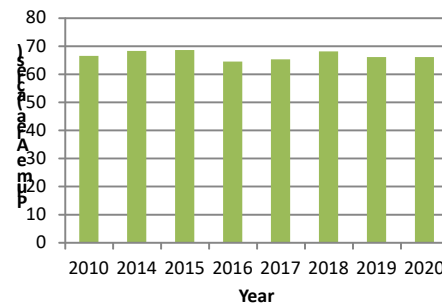
Downgradient Arsenic Plume Area Trend

Year	Planar Area (acres)	Average Arsenic Concentration (mg/L)
2010	66	0.203
2014	68	0.167
2015	68	0.175
2016	64	0.167
2017	65	0.173
2018	68	0.211
2019	66	0.203
2020	66	0.173
