# Former ASARCO Smelter East Helena Facility Annual Project Update

**December 8, 2021 - Public Meeting**

**US Environmental Protection Agency**

**Montana Environmental Trust Group**

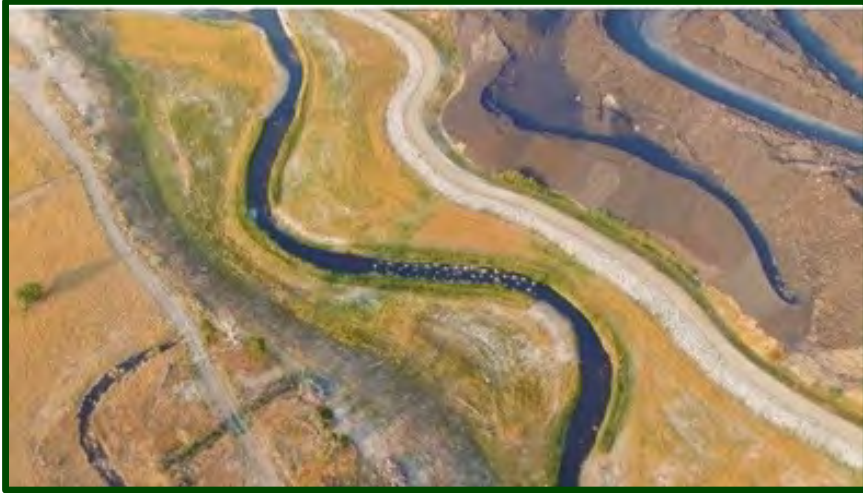
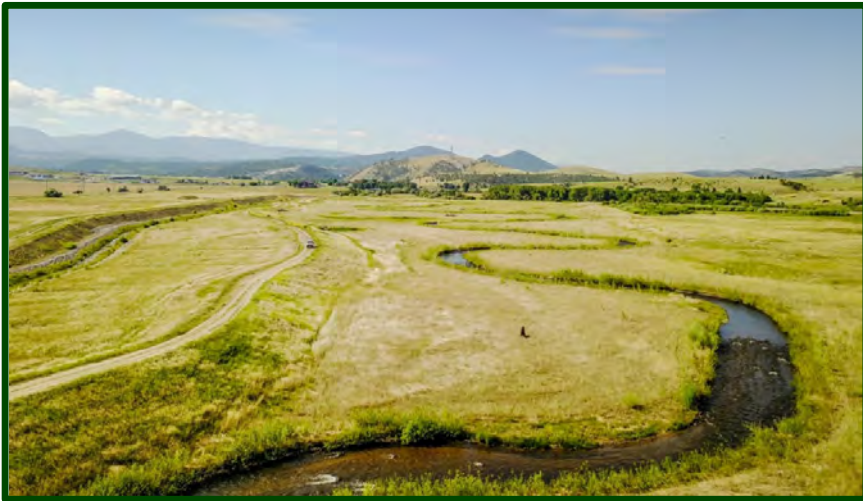
# Results of East Helena Corrective Actions

- Demonstrably reduced contaminant concentrations in groundwater
- Replaced remnants of former smelter with graded, vegetated, self-sustaining ET Cover
- Eliminated need to treat impacted stormwater that is now shed clean
- Created enhanced riparian habitat and scenic open space
- Removed failing smelter dam and last remaining impediment to fish passage in PPC
- Created flood storage capacity to mitigate flooding in downstream flood-prone areas of East Helena
- Moved PPC away from Slag Pile

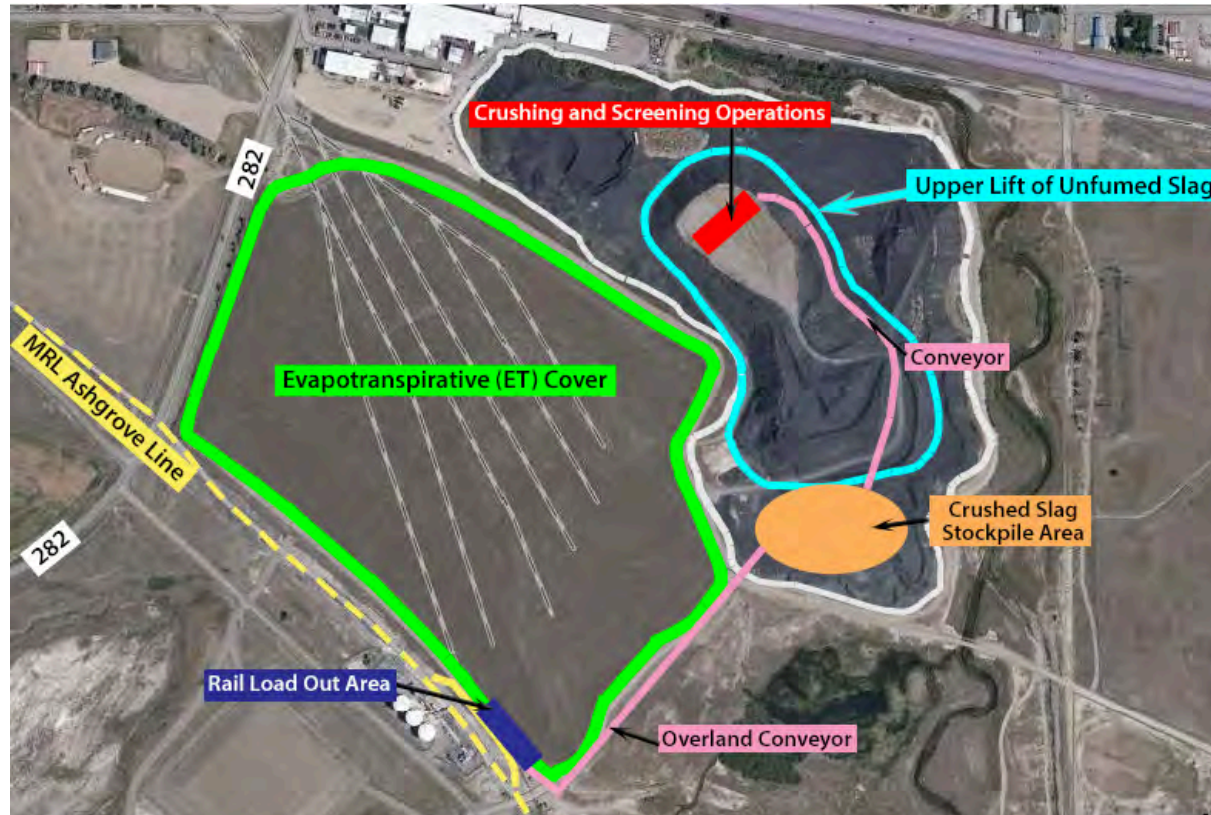
# Unfumed Slag Removal Project

- METG partnered with Metallica
- Remove “upper lift” - 2 million tons of unfumed (zinc-bearing) slag
  - Crush to 2 inches
  - Transport by conveyor from crushing area to stockpile
- Transport from stockpile to rail loadout by overland conveyor
  - Weigh and load onto railcars

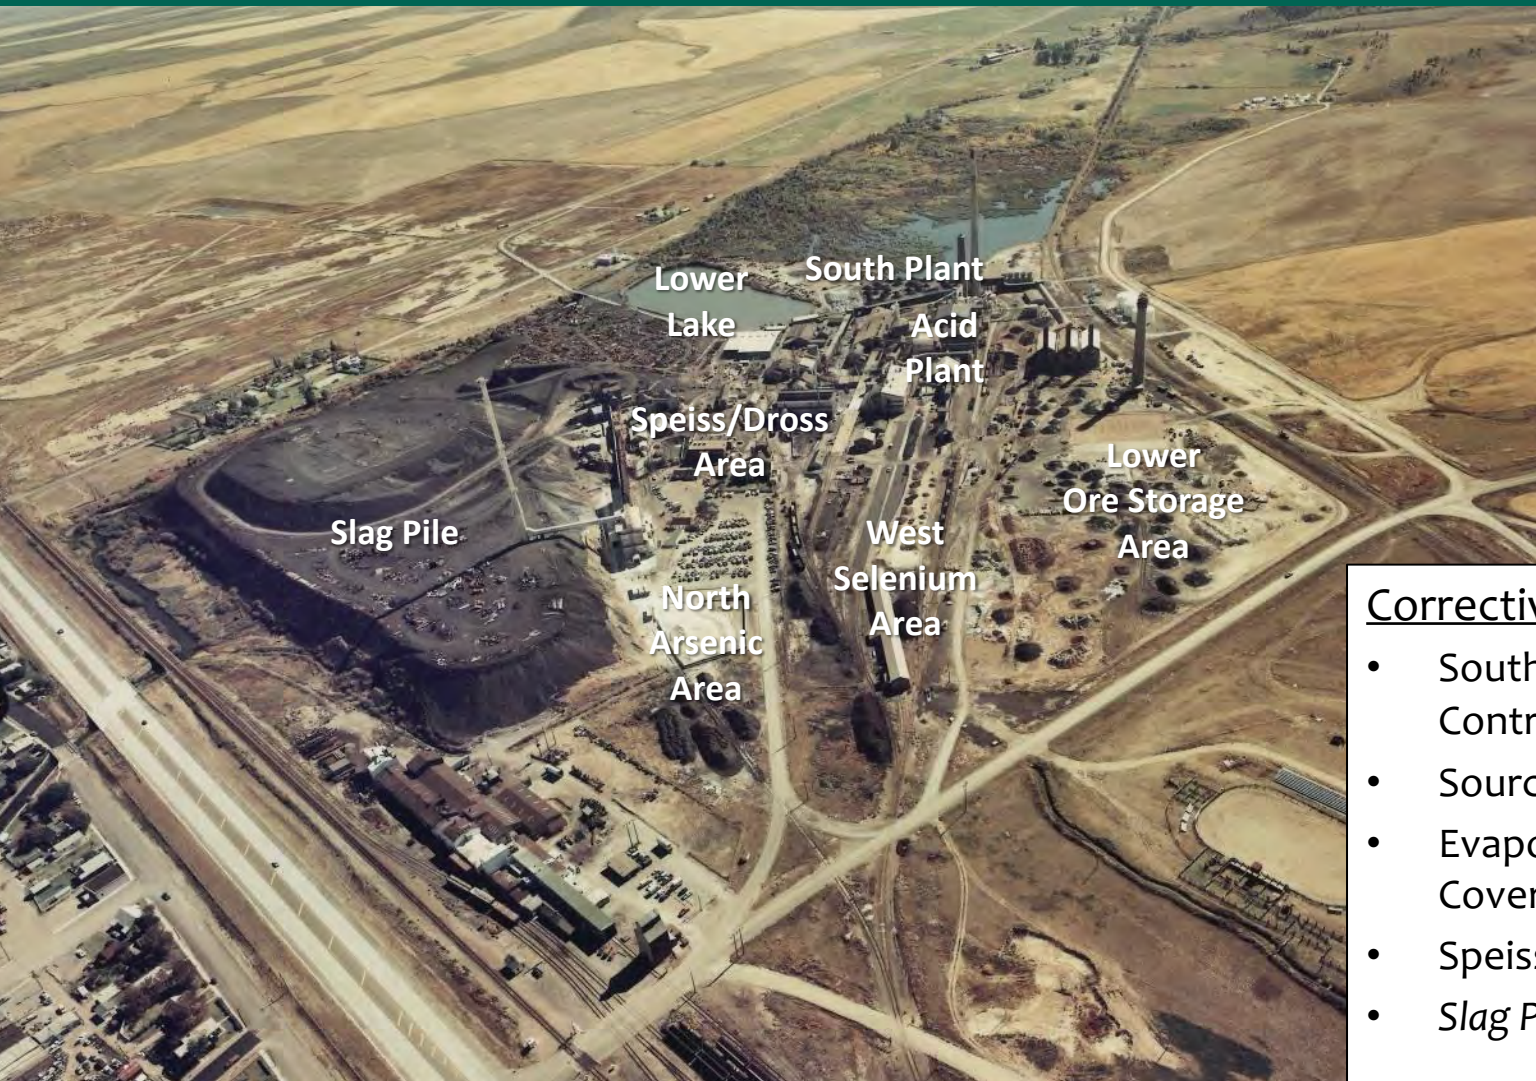
# Groundwater Contaminant Source Areas Addressed by Corrective Measures

- South Plant Hydraulic Control (SPHC)
- Source Removals
- Evapotranspiration (ET) Cover
- Speiss-Dross Slurry Wall
- *Slag Pile Cover (Planned)*

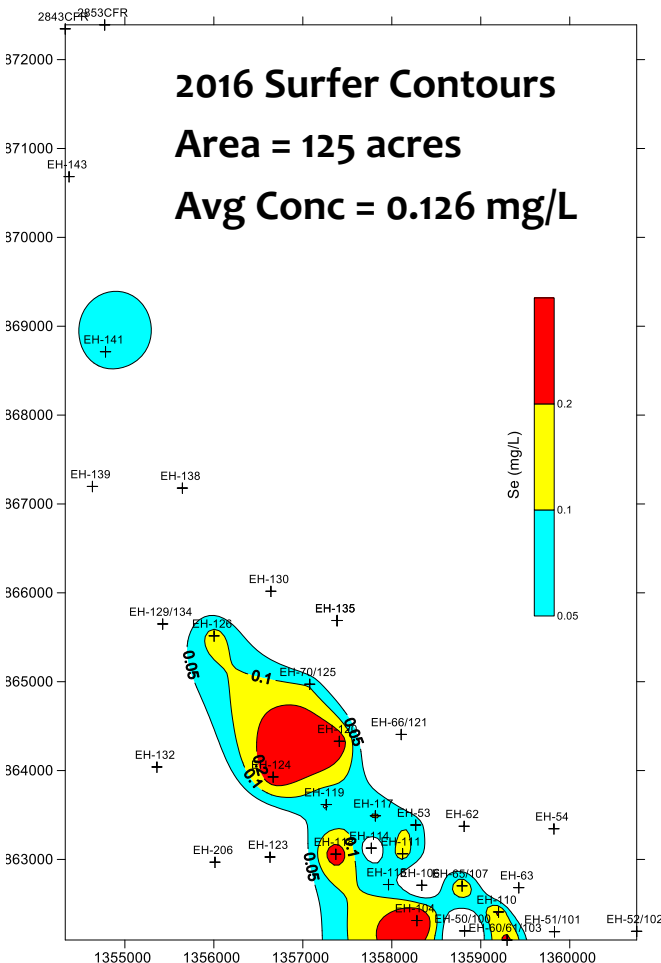
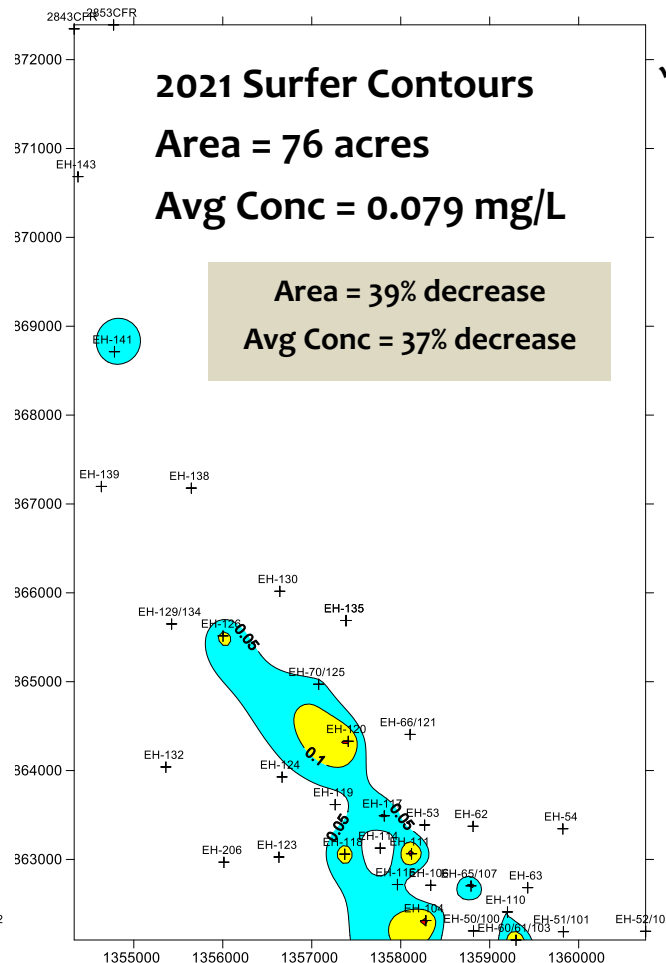
# Selenium Plume Metrics - 2016 and 2021

## Highway 12 to Canyon Ferry Road

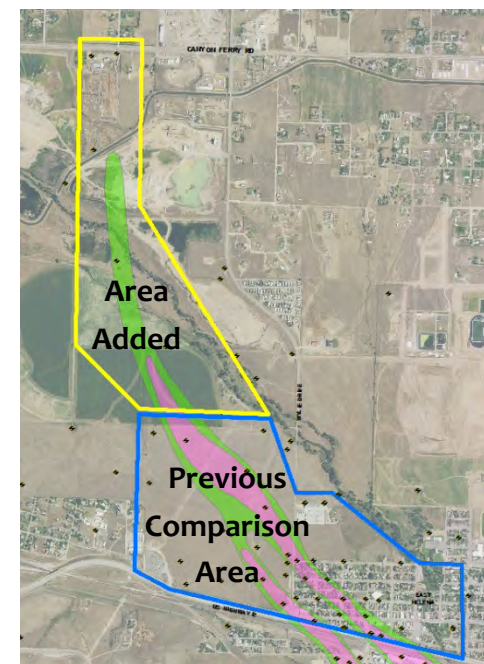
✓ With sufficient downgradient data, plume metric comparison area will be expanded as shown for future comparisons
